OIL ANALYSIS REPORT

Machine Id
GOODYEAR AKRON TEST 41
Component
Hydraulic System
Fluid
CONOCO MEGAFLOW AW 46 (--- GAL)

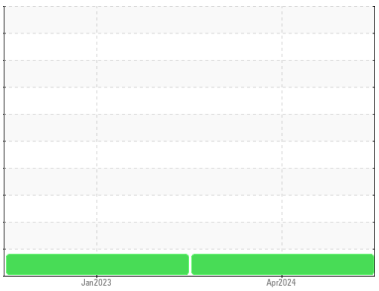
Sample Rating Trend

Wear
The copper level is abnormal. All other component wear rates are normal.

Recommendation
No corrective action is recommended at this time. Resample at the next service interval to monitor.
