Customer Id: CIMCAR
Sample No.: TO90004171
Lab Number: 06156057
Test Package: IND 2

OIL ANALYSIS REPORT

Machine Id
NK 112614
Component
Compressor
Fluid
{not provided} (--- GAL)

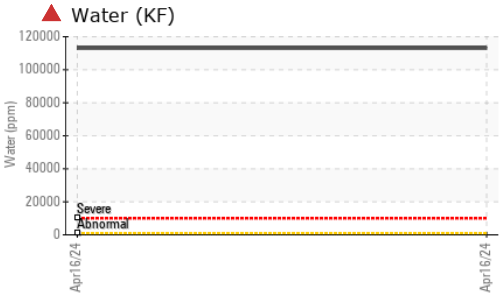
Water (KF)

▲ Contamination
There is a high amount of particulates present in the oil. There is a high concentration of water present in the oil.

CONTAMINANTS		method	limit/base	current	history1	history2
Silicon	ppm	ASTM D5185m	>25	**3**	---	---
Sodium	ppm	ASTM D5185m		**8**	---	---
Potassium	ppm	ASTM D5185m	>20	**1**	---	---
Water	%	ASTM D6304	>0.1	▲ **11.30**	---	---
ppm Water	ppm	ASTM D6304	>1000	▲ **113046**	---	---

We advise that you follow the water drain-off procedure for this component, and use off-line filtration to improve the cleanliness of the system fluid. We recommend an early resample to monitor this condition.

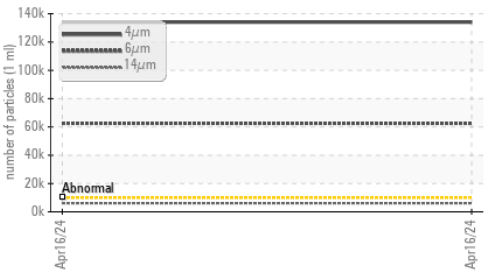
Particle Trend

FLUID CLEANLINESS		method	limit/base	current	history1	history2
Particles >4µm		ASTM D7647	>10000	▲ **134016**	---	---
Particles >6µm		ASTM D7647	>2500	▲ **62560**	---	---
Particles >14µm		ASTM D7647	>320	▲ **6079**	---	---
Particles >21µm		ASTM D7647	>80	▲ **1842**	---	---
Particles >38µm		ASTM D7647	>20	▲ **206**	---	---
Particles >71µm		ASTM D7647	>4	▲ **29**	---	---
Oil Cleanliness		ISO 4406 (c)	>20/18/15	▲ **24/23/20**	---	---

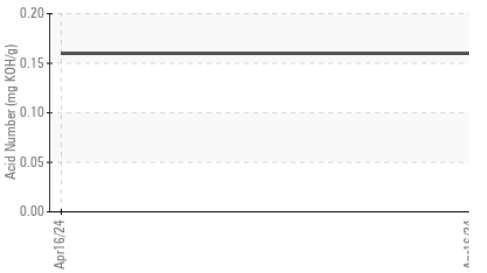
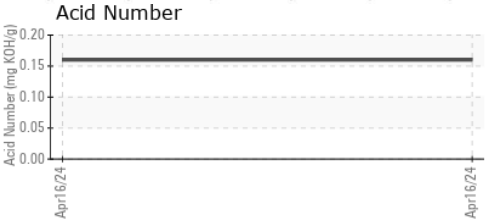
Acid Number

Fluid Condition
The AN level is acceptable for this fluid.
