OIL ANALYSIS REPORT

Area
[W02008217]
Machine Id
VOLVO L90H 623805
Component
Front Axle
Fluid
VOLVO WB 102 (9 GAL)

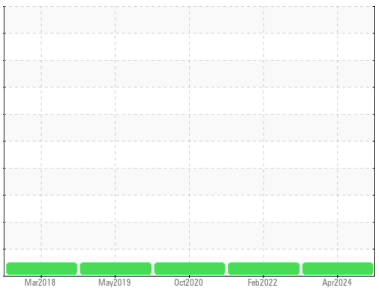
Sample Rating Trend

NORMAL

Wear
All component wear rates are normal.

Contamination
There is no indication of any contamination in the oil.

Fluid Condition
The condition of the oil is acceptable for the time in service.

Recommendation
Resample at the next service interval to monitor. (Customer Sample Comment: W02008217)
