Hilcorp Alaska, LLC

OIL ANALYSIS REPORT

Area
IRIG [7008231]
Machine Id
IRIG-SS-HPU-2301 IRIG-SS-HPU-2301 SUB HYDRAULIC POWER UNIT
Component
Hydraulic System
Fluid
MOBIL DTE 10 EXCEL 32 (400 GAL)

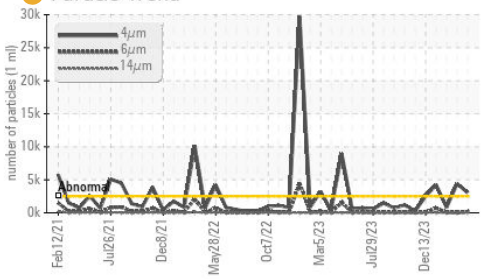
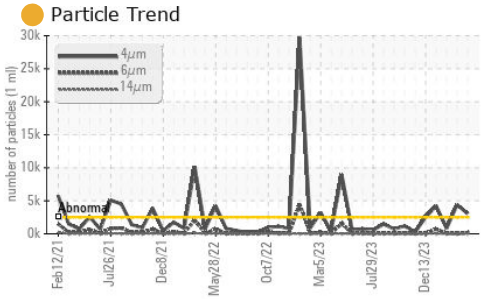
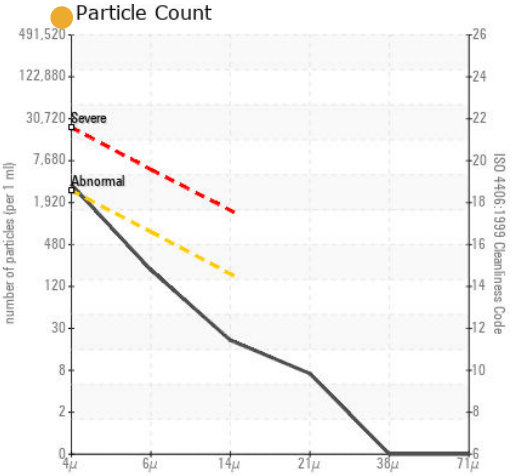
Particle Trend

Contamination
There is a moderate amount of silt (particulates < 14 microns in size) present in the oil.

FLUID CLEANLINESS		method	limit/base	current	history1	history2
Particles >4µm		ASTM D7647	>2500	**3051**	4411	821
Particles >6µm		ASTM D7647	>640	**183**	30	97
Particles >14µm		ASTM D7647	>160	**18**	3	7
Particles >21µm		ASTM D7647	>40	**6**	1	2
Particles >38µm		ASTM D7647	>10	**0**	0	0
Particles >71µm		ASTM D7647	>3	**0**	0	0
Oil Cleanliness		ISO 4406 (c)	>18/16/14	**19/15/11**	19/12/9	17/14/10

Recommendation
No corrective action is recommended at this time. The filtration at the time of sampling has been noted. Resample at the next service interval to monitor.
