OIL ANALYSIS REPORT

Machine Id
RK TRUCK-9/313
Component
Hydraulic System
Fluid
AW HYDRAULIC OIL ISO 22 (--- LTR)

Laboratory : WearCheck USA - 501 Madison Ave., Cary, NC 27513
Sample No. : WC0930900
Lab Number : 06176399
Unique Number : 11022452
Test Package : FLEET

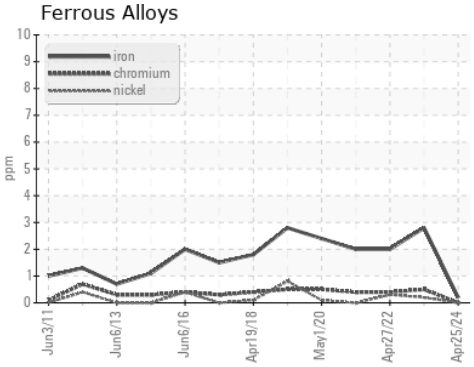
Ferrous Alloys

Wear
All component wear rates are normal.

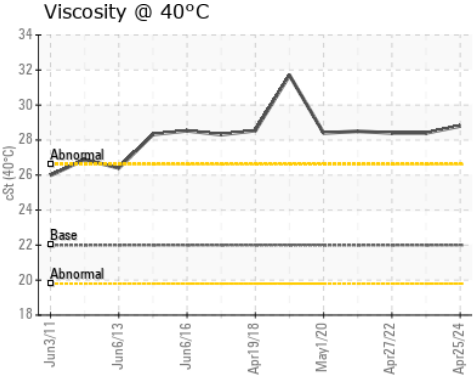
Viscosity @ 40°C

Fluid Condition
The condition of the oil is acceptable for the time in service.
