OIL ANALYSIS REPORT

Machine Id
ROSENBAUER 457
Component
Hydraulic System
Fluid
AW HYDRAULIC OIL ISO 32 (--- LTR)

Laboratory : WearCheck USA - 501 Madison Ave., Cary, NC 27513
Sample No. : WC0930898
Lab Number : 06176402
Unique Number : 11022455
Test Package : FLEET

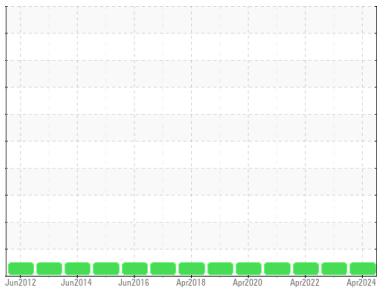
Sample Rating Trend

NORMAL

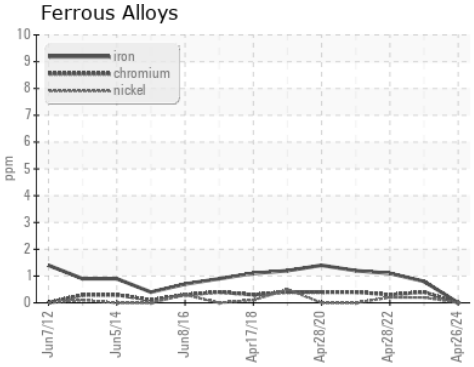
Ferrous Alloys

Wear
All component wear rates are normal.

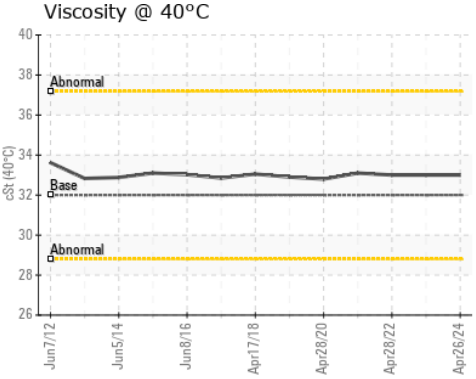
Viscosity @ 40°C

Fluid Condition
The condition of the oil is acceptable for the time in service.
