OIL ANALYSIS REPORT

Area
DE Samples - CAT LAB
Machine Id
KOMATSU 605 HAUL TRUCK 6524 (S/N 10126)
Component
Diesel Engine
Fluid
TULCO LUBSOIL CK-4 15W40 (--- GAL)

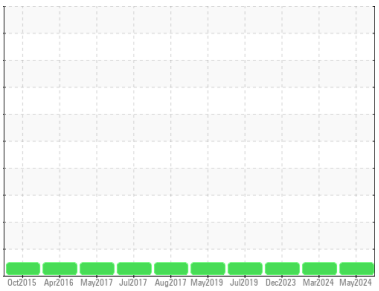
Sample Rating Trend

NORMAL

Wear
All component wear rates are normal.

Contamination
There is no indication of any contamination in the oil.

Fluid Condition
The BN result indicates that there is suitable alkalinity remaining in the oil. The condition of the oil is suitable for further service.

Recommendation
Resample at the next service interval to monitor.
