OIL ANALYSIS REPORT

Area
RIG 274
Machine Id
R274-MP-03
Component
Gearbox
Fluid
{not provided} (--- GAL)

Laboratory : WearCheck USA - 501 Madison Ave., Cary, NC 27513
Sample No. : KL0014284
Lab Number : 06181296
Unique Number : 11032622
Test Package : MOB 2 (Additional Tests: PrtCount)

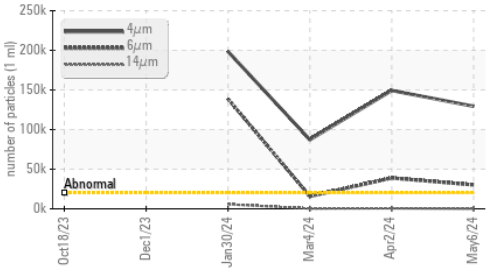
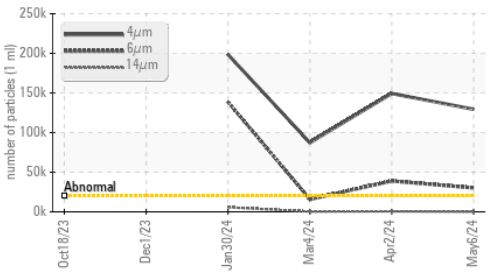
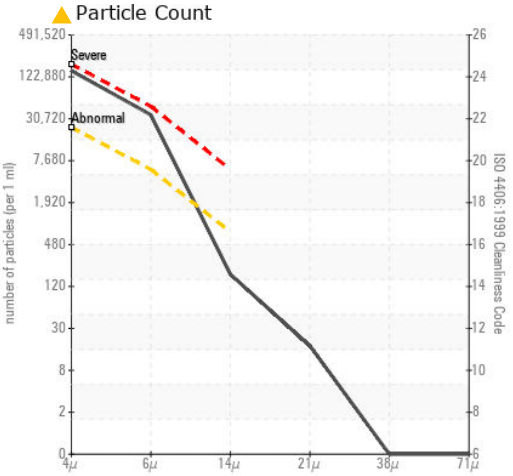
Contamination
There is a moderate amount of silt (particulates < 14 microns in size) present in the oil. The system cleanliness is above the acceptable limit for the target ISO 4406 cleanliness code.

FLUID CLEANLINESS		method	limit/base	current	history1	history2
Particles >4µm		ASTM D7647	>20000	▲ **129409**	▲ 149313	▲ 87204
Particles >6µm		ASTM D7647	>5000	▲ **30242**	▲ 38955	▲ 15794
Particles >14µm		ASTM D7647	>640	**158**	625	303
Particles >21µm		ASTM D7647	>160	**15**	112	43
Particles >38µm		ASTM D7647	>40	**0**	2	1
Particles >71µm		ASTM D7647	>10	**0**	0	0
Oil Cleanliness		ISO 4406 (c)	>21/19/16	▲ **24/22/14**	▲ 24/22/16	▲ 24/21/15

Recommendation
We recommend you service the filters on this component. We recommend an early resample to monitor this condition. Please specify the component make and model with your next sample. Please specify the brand, type, and viscosity of the oil on your next sample.
