Machine Id
KAESER 7356398
Component
Compressor
Fluid
KAESER SIGMA (OEM) M-460 (--- GAL)

Customer Id: MARGOLCA
Sample No.: KCPA017212
Lab Number: 06193979
Test Package: IND 2

OIL ANALYSIS REPORT

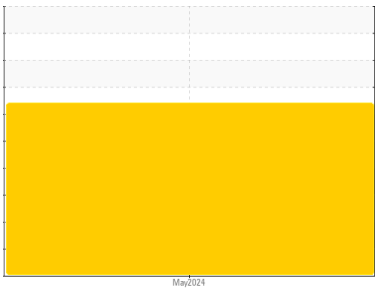
Sample Rating Trend

WATER

Sample Status				**SEVERE**	---	---
Water	%	ASTM D6304	>0.05	▲ **0.180**	---	---
ppm Water	ppm	ASTM D6304	>500	▲ **1800**	---	---
Emulsified Water	scalar	*Visual	>0.05	▲ **0.2%**	---	---
Free Water	scalar	*Visual		▲ **>10%**	---	---

Oil and filter change at the time of sampling has been noted. We recommend an early resample in 500 hours to monitor this condition.

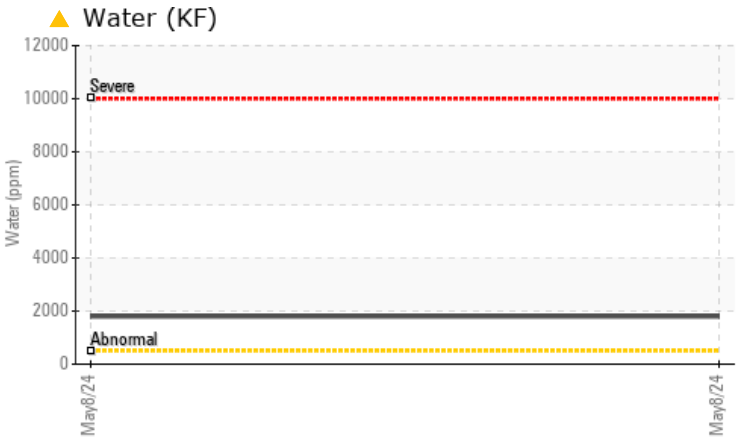
COMPONENT CONDITION SUMMARY

▲ Contamination
Excessive free water present. There is a light concentration of water present in the oil. The amount and size of particulates present in the system are acceptable.

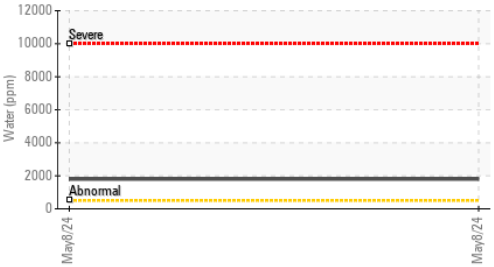
Water (KF)

CONTAMINANTS		method	limit/base	current	history1	history2
Silicon	ppm	ASTM D5185m	>25	**2**	---	---
Sodium	ppm	ASTM D5185m		**2**	---	---
Potassium	ppm	ASTM D5185m	>20	**2**	---	---
Water	%	ASTM D6304	>0.05	▲ **0.180**	---	---
ppm Water	ppm	ASTM D6304	>500	▲ **1800**	---	---

▲ Recommendation
Oil and filter change at the time of sampling has been noted. We recommend an early resample in 500 hours to monitor this condition.
