OIL ANALYSIS REPORT

Machine Id
HBKM01BE
Component
Biogas Engine
Fluid
SHELL MYSELLA S5 S (--- GAL)

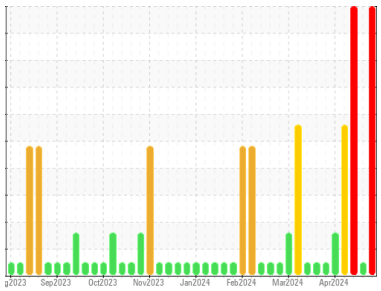
Sample Rating Trend

▲ Wear
The tin level is severe. The aluminum level is abnormal.

▲ Contamination
Elemental level of silicon (Si) above normal.

▲ Recommendation
We recommend that you drain the oil and perform a filter service on this component if not already done. We advise that you inspect for the source(s) of wear. We recommend an early resample to monitor this condition. (Customer Sample Comment: Top Up Amount: 30 GAL)
