OIL ANALYSIS REPORT

Machine Id
JOHN DEERE 1025R 1LV1025RVHH136002
Component
Hydraulic System
Fluid
JOHN DEERE HY-GARD HYD/TRANS LOW VIS (--- QTS)

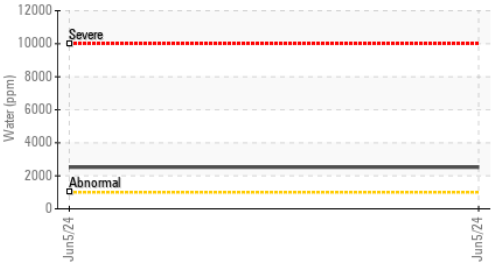
Water (KF)

Contamination
There is a high amount of particulates present in the oil. There is a light concentration of water present in the oil.

CONTAMINANTS		method	limit/base	current	history1	history2
Silicon	ppm	ASTM D5185m	>20	**13**	---	---
Sodium	ppm	ASTM D5185m		**2**	---	---
Potassium	ppm	ASTM D5185m	>20	**3**	---	---
Water	%	ASTM D6304	>0.1	▲ **0.252**	---	---
ppm Water	ppm	ASTM D6304	>1000	▲ **2520**	---	---

Recommendation
We advise that you check for the source of water entry. We recommend you service the filters on this component. We recommend an early resample to monitor this condition.

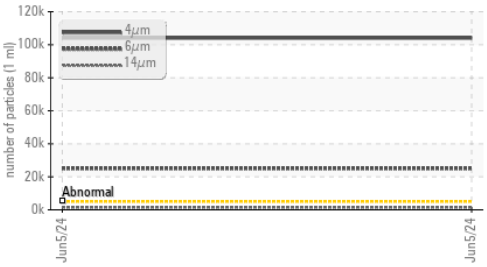
Particle Trend

FLUID CLEANLINESS		method	limit/base	current	history1	history2
Particles >4µm		ASTM D7647	>5000	**104060**	---	---
Particles >6µm		ASTM D7647	>1300	▲ **25093**	---	---
Particles >14µm		ASTM D7647	>160	▲ **1418**	---	---
Particles >21µm		ASTM D7647	>40	▲ **371**	---	---
Particles >38µm		ASTM D7647	>10	▲ **25**	---	---
Particles >71µm		ASTM D7647	>3	**1**	---	---
Oil Cleanliness		ISO 4406 (c)	>19/17/14	▲ **24/22/18**	---	---

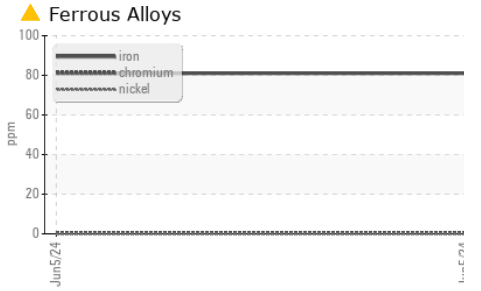
Ferrous Alloys

Wear
The iron level is abnormal.

WEAR METALS		method	limit/base	current	history1	history2
PQ		ASTM D8184		**23**	---	---
Iron	ppm	ASTM D5185m	>20	▲ **81**	---	---
Chromium	ppm	ASTM D5185m	>10	**<1**	---	---
Nickel	ppm	ASTM D5185m	>10	**<1**	---	---
Titanium	ppm	ASTM D5185m		**<1**	---	---
Silver	ppm	ASTM D5185m		**0**	---	---
Aluminum	ppm	ASTM D5185m	>10	**2**	---	---
Lead	ppm	ASTM D5185m	>10	**4**	---	---
Copper	ppm	ASTM D5185m	>75	**38**	---	---
Tin	ppm	ASTM D5185m	>10	**1**	---	---
Vanadium	ppm	ASTM D5185m		**0**	---	---
Cadmium	ppm	ASTM D5185m		**<1**	---	---
