# OIL ANALYSIS REPORT

Machine Id
## KAESER 8097866
Component
**Compressor**
Fluid
**KAESER SIGMA (OEM) M-460 (--- GAL)**

| SAMPLE INFORMATION | | method | limit/base | current | history1 | history2 |
|---|---|---|---|---|---|---|
| Sample Number | | Client Info | | **KCPA017875** | --- | --- |

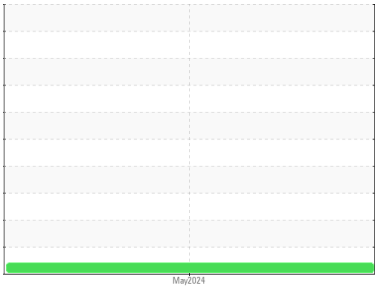
VISCOSITY

**Fluid Condition**
The oil viscosity is higher than normal. The AN level is acceptable for this fluid.

**Recommendation**
Oil and filter change at the time of sampling has been noted. Resample at the next service interval to monitor.
