OIL ANALYSIS REPORT

Area
RIG 274
Machine Id
R274-MP-03
Component
Gearbox
Fluid
{not provided} (--- GAL)

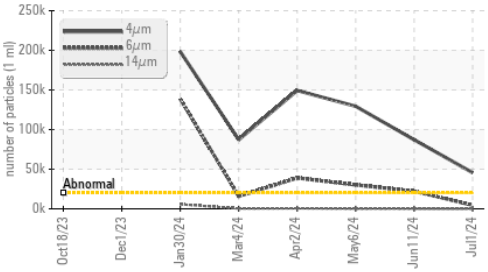
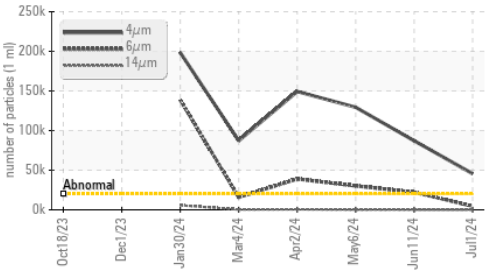
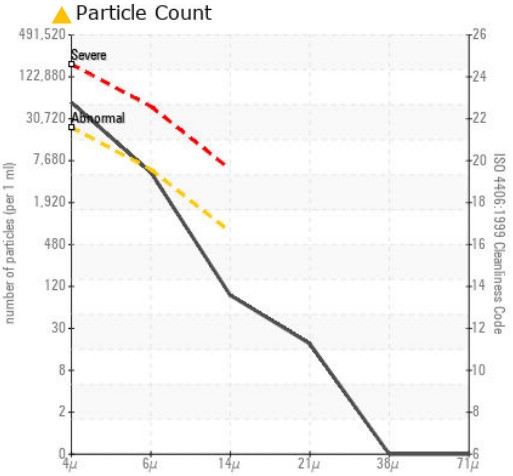
Particle Trend

Contamination
There is a moderate amount of silt (particulates < 14 microns in size) present in the oil. The system cleanliness is above the acceptable limit for the target ISO 4406 cleanliness code.

FLUID CLEANLINESS		method	limit/base	current	history1	history2
Particles >4µm		ASTM D7647	>20000	▲ **45606**	▲ 87152	▲ 129409
Particles >6µm		ASTM D7647	>5000	**4541**	▲ 22135	▲ 30242
Particles >14µm		ASTM D7647	>640	**79**	148	158
Particles >21µm		ASTM D7647	>160	**16**	20	15
Particles >38µm		ASTM D7647	>40	**0**	1	0
Particles >71µm		ASTM D7647	>10	**0**	0	0
Oil Cleanliness		ISO 4406 (c)	>21/19/16	▲ **23/19/13**	▲ 24/22/14	▲ 24/22/14

Recommendation
We recommend you service the filters on this component. We recommend an early resample to monitor this condition. Please specify the component make and model with your next sample. Please specify the brand, type, and viscosity of the oil on your next sample.
