Machine Id
AIR 2
Component
Air Compressor
Fluid
{not provided} (--- GAL)

Customer Id: CARFORCO
Sample No.: USP0012341
Lab Number: 06236872
Test Package: IND 2

OIL ANALYSIS REPORT

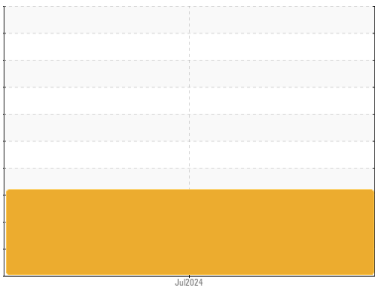
Sample Rating Trend

DEGRADATION

Sample Status				SEVERE	---	---
Acid Number (AN)	mg KOH/g	ASTM D8045		▲ 8.747	---	---

Recommend drain oil if not already done and flush with cleaner before refilling with oil. We recommend an early resample to monitor this condition.

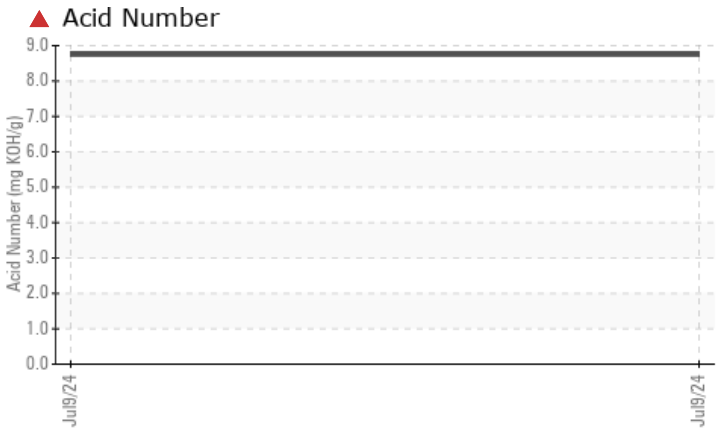
▲ Fluid Condition
The AN level is above the recommended limit. Confirmed.
