Customer Id: KROFOR
Sample No.: KCP48112
Lab Number: 05623884
Test Package: IND 2

OIL ANALYSIS REPORT

Machine Id
KAESER SK 15 5319317 (S/N 1055)
Component
Compressor
Fluid
KAESER SIGMA (OEM) S-460 (--- GAL)

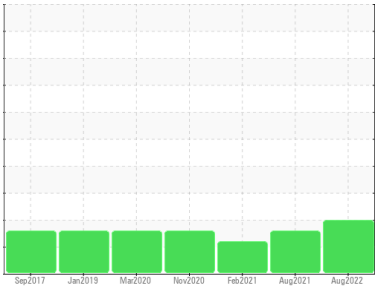
Sample Rating Trend

Sample Status				**ABNORMAL**	ABNORMAL	ABNORMAL
Particles >6µm		ASTM D7647	>1300	▲ **46146**	▲ 50677	1145
Particles >14µm		ASTM D7647	>20	▲ **4729**	▲ 4487	▲ 150
Particles >21µm		ASTM D7647	>4	▲ **764**	▲ 788	▲ 58
Particles >38µm		ASTM D7647	>3	▲ **29**	▲ 21	▲ 6
Oil Cleanliness		ISO 4406 (c)	>17/11	▲ **23/19**	▲ 23/19	▲ 17/14

No corrective action is recommended at this time. The filter change at the time of sampling has been noted. Resample at the next service interval to monitor.

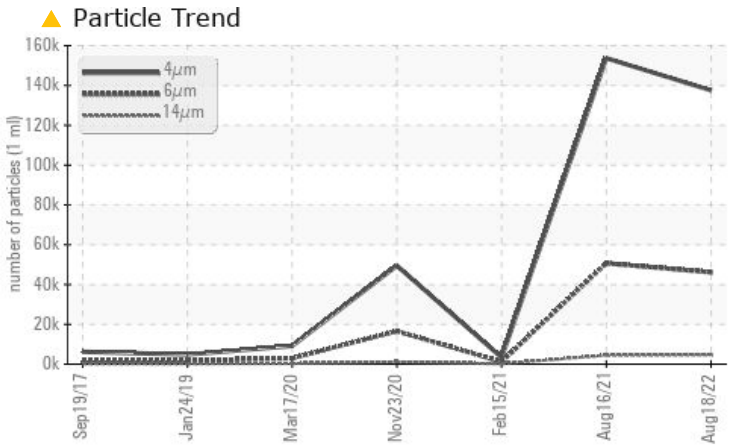
COMPONENT CONDITION SUMMARY

Contamination
There is a high amount of particulates present in the oil.

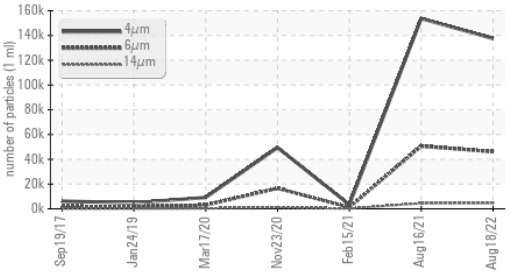
Particle Trend

FLUID CLEANLINESS		method	limit/base	current	history 1	history 2
Particles >4µm		ASTM D7647		**137539**	153695	3306
Particles >6µm		ASTM D7647	>1300	▲ **46146**	▲ 50677	1145
Particles >14µm		ASTM D7647	>20	▲ **4729**	▲ 4487	▲ 150
Particles >21µm		ASTM D7647	>4	▲ **764**	▲ 788	▲ 58
Particles >38µm		ASTM D7647	>3	▲ **29**	▲ 21	▲ 6
Particles >71µm		ASTM D7647	>3	**1**	0	0
Oil Cleanliness		ISO 4406 (c)	>17/11	▲ **23/19**	▲ 23/19	▲ 17/14

Recommendation
No corrective action is recommended at this time. The filter change at the time of sampling has been noted. Resample at the next service interval to monitor.
