Machine Id
100755.1 (S/N 1417)
Component
Compressor
Fluid
KAESER SIGMA (OEM) M-460 (--- GAL)

Customer Id: MACASH
Sample No.: KCP28639
Lab Number: 05633661
Test Package: IND 2

OIL ANALYSIS REPORT

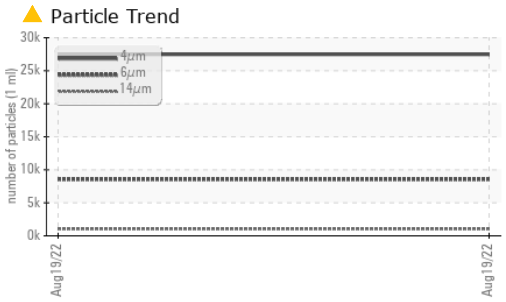
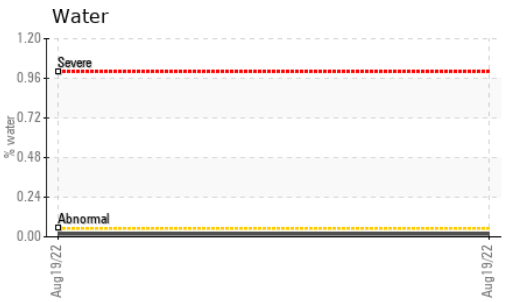
Contamination
There is a high amount of particulates present in the oil.

FLUID CLEANLINESS	method	limit/base	current	history 1	history 2
Particles >4µm	ASTM D7647		**27474**	---	---
Particles >6µm	ASTM D7647	>1300	▲ **8561**	---	---
Particles >14µm	ASTM D7647	>80	▲ **1032**	---	---
Particles >21µm	ASTM D7647	>20	▲ **255**	---	---
Particles >38µm	ASTM D7647	>4	▲ **24**	---	---
Particles >71µm	ASTM D7647	>3	**2**	---	---
Oil Cleanliness	ISO 4406 (c)	>--/17/13	▲ **22/20/17**	---	---

Recommendation
No corrective action is recommended at this time. Oil and filter change at the time of sampling has been noted. Resample at the next service interval to monitor.
