Customer Id: VALFAY
Sample No.: KCP30946
Lab Number: 05635033
Test Package: IND 2

OIL ANALYSIS REPORT

Machine Id
KAESER ASD 40 6366254 (S/N 1493)
Component
Compressor
Fluid
KAESER SIGMA (OEM) S-460 (--- GAL)

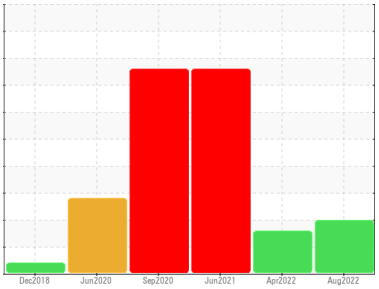
Sample Rating Trend

WATER

Sample Status				**ABNORMAL**	ABNORMAL	SEVERE
Water	%	ASTM D6304	>0.05	▲ **0.204**	0.012	▲ 0.494
ppm Water	ppm	ASTM D6304	>500	▲ **2040**	126.1	▲ 4940
Debris	scalar	*Visual	NONE	▲ **MODER**	LIGHT	▲ MODER
Emulsified Water	scalar	*Visual	>0.05	▲ **0.2%**	NEG	NEG

The filter change at the time of sampling has been noted. We advise that you stop the unit and follow the water drain-off procedure for this component. We recommend an early resample in 500 hours to monitor this condition. We were unable to perform a particle count due to a high concentration of particles present in this sample.

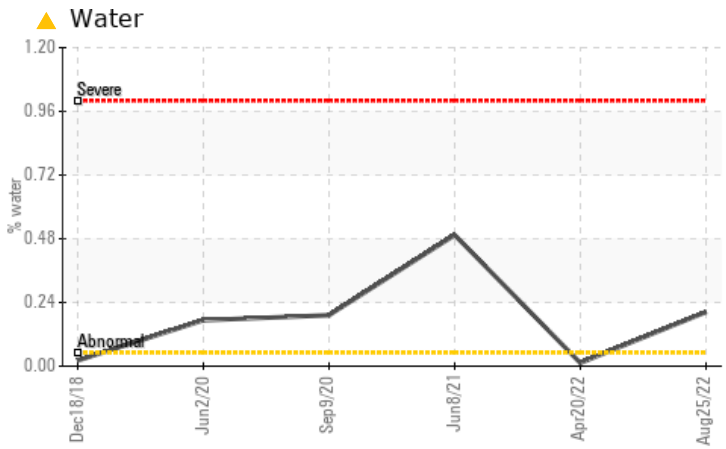
COMPONENT CONDITION SUMMARY

Wear
All component wear rates are normal.

Contamination
Moderate concentration of visible dirt/debris present in the oil. There is a light concentration of water present in the oil.

Fluid Condition
The AN level is acceptable for this fluid.

Recommendation
The filter change at the time of sampling has been noted. We advise that you stop the unit and follow the water drain-off procedure for this component. We recommend an early resample in 500 hours to monitor this condition. We were unable to perform a particle count due to a high concentration of particles present in this sample.

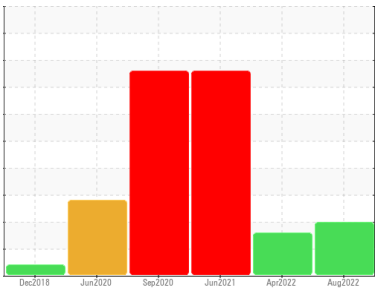
Sample Rating Trend

WATER

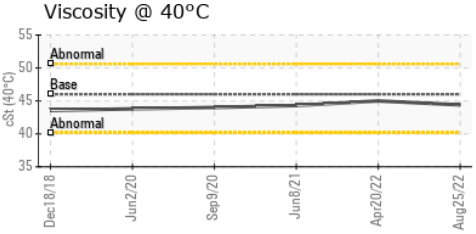
Viscosity @ 40°C

FLUID PROPERTIES		method	limit/base	current	history 1	history 2
Visc @ 40°C	cSt	ASTM D445	46	**44.4**	45.0	44.3
