PROBLEM SUMMARY

Machine Id
KAESER SK-19 2192153 (S/N 1700)
Component
Compressor
Fluid
KAESER SIGMA (OEM) S-460 (--- GAL)

OIL ANALYSIS REPORT

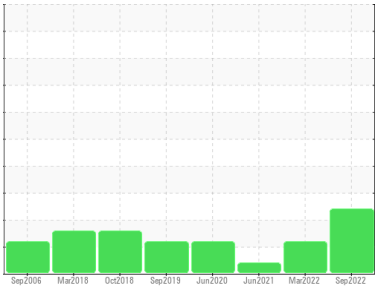
Sample Rating Trend

Sample Status				**ABNORMAL**	ABNORMAL	ABNORMAL
Particles >6µm		ASTM D7647	>1300	▲ **1717**	827	---
Particles >14µm		ASTM D7647	>80	▲ **368**	▲ 273	---
Particles >21µm		ASTM D7647	>20	▲ **150**	▲ 100	---
Particles >38µm		ASTM D7647	>4	▲ **12**	▲ 17	---
Particles >71µm		ASTM D7647	>3	▲ **2**	0	---
Oil Cleanliness		ISO 4406 (c)	>--/17/13	▲ **20/18/16**	▲ 17/15	---

Oil and filter change at the time of sampling has been noted. Resample at the next service interval to monitor.

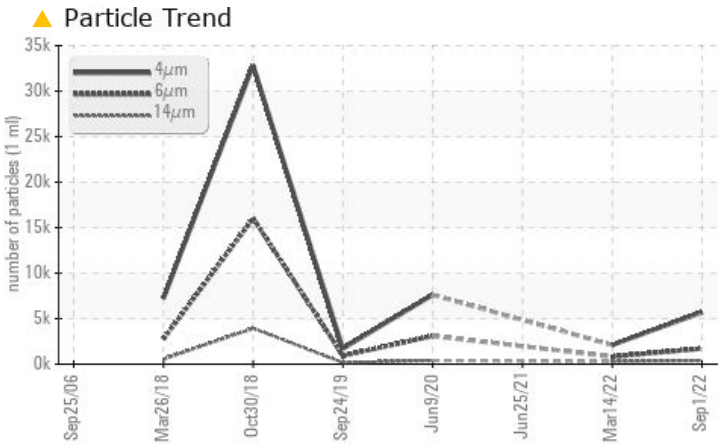
▲ Particle Trend

Contamination
There is a high amount of particulates present in the oil.
