## TFS H/O SYSTEM #2

Customer: PTRHTF10176	System Information	Sample Information
CERTAINTEED ROOFING	System Volume: 3738 gal	Lab No: 02211309
100 CERTAINTEED DR	Bulk Operating Temp: 525F / 274C	Analyst: Gaston Arseneault
JONESBURG, MO 63351 USA	Heating Source:	Sample Date: 04/09/18
Attn: Randy Smith	Blanket:	Received Date: 04/20/18
Tel: (636)791-3651	Fluid: PETRO CANADA CALFLO AF	Completed: 05/16/18
E-Mail: randy.smith@saint-gobain.com	Make: FSE	To discuss this report contact Gaston
		Arseneault at 973-986-6503

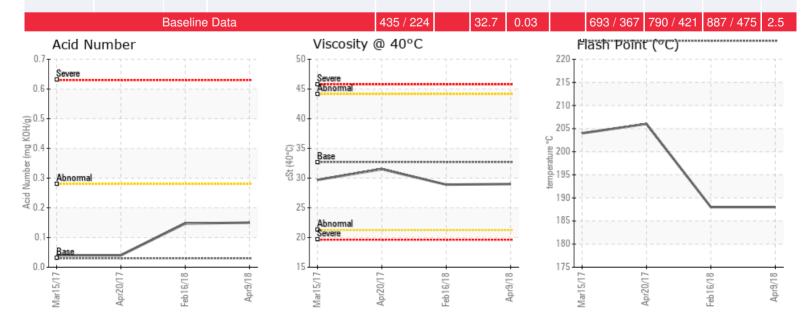
Recommendation: The results are almost identical to the satisfactory results from a couple months ago. No action needed at this time besides re-sampling in about 6-9 months time.

Comments: COC Flash Point is marginally low.
