SUPPLY CARGILL MEAT THAILAND

Customer: PTRHTF60010	System Information	Sample Information
SYNLUBE INTERNATIONAL CO LTD 76/1 MOO.7 THACHIN MUANG SAMUTSAKHON, 74000 THAILAND Attn: Kittisak Suthithanakom Tel: 6(681)850-1907 E-Mail: kittisak@synlube.co.th	System Volume: 9635 ltr Bulk Operating Temp: 554F / 290C Heating Source: Blanket: Fluid: PETRO CANADA PURITY FG HEAT TRANSFER FLUID Make: WANSON	Lab No: 02221715 Analyst: Yutong Gao Sample Date: 05/23/18 Received Date: 06/12/18 Completed: 06/17/18 To discuss this report contact Yutong Gao at (403)873-1876

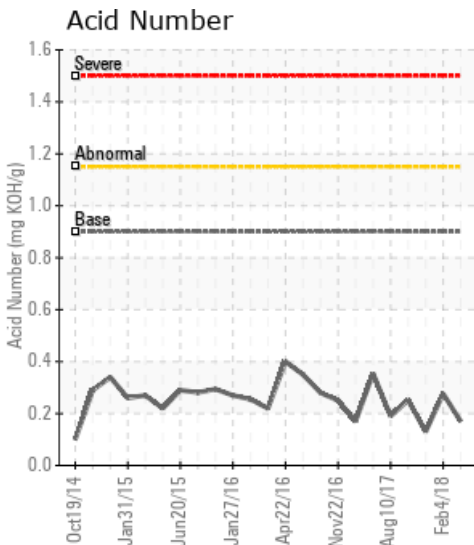
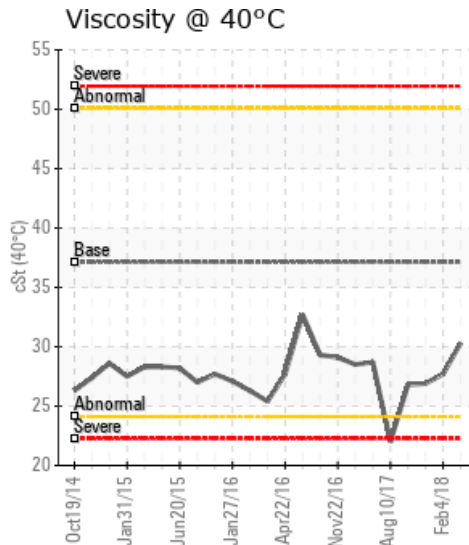
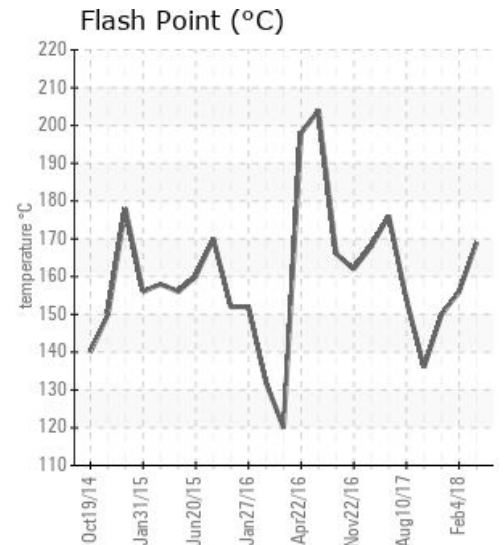
Recommendation: The currently fluid has experienced severe thermal cracking at the extremely high bulk working temperature. However, the fluid flash point and viscosity are all higher than the previous three used oil samples, so the overall fluid conditions are improving. Please continue to do the effective system venting and take one sample in 6 months to monitor the conditions.

Comments: COC Flash Point is severely low. (GCD) 90% Distillation Point is marginally low.
