LINE 2

Customer: PTRHTF20031	System Information	Sample Information
MCCAIN FOODS PORTAGE PO BOX 220 1 McCain Avenue PORTAGE LA PRARIE, MB R1N 3B5 Canada Attn: Mark Nelissen Tel: x:	System Volume: 62000 ltr Bulk Operating Temp: 540F / 282C Heating Source: Blanket: Fluid: PETRO CANADA PETRO-THERM Make: VOLCANO	Lab No: 02233911 Analyst: Yutong Gao Sample Date: 08/12/18 Received Date: 08/15/18 Completed: 08/29/18 To discuss this report contact Yutong Gao at (403)873-1876

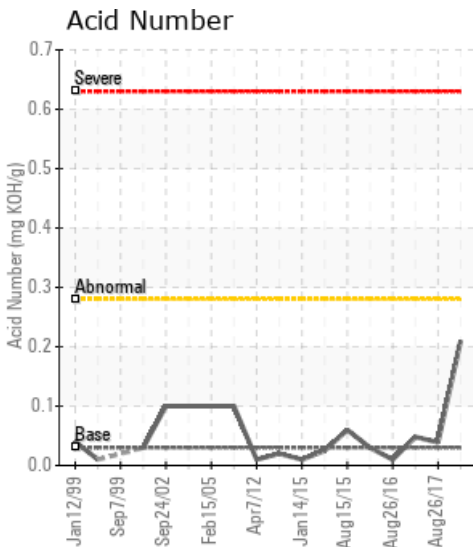
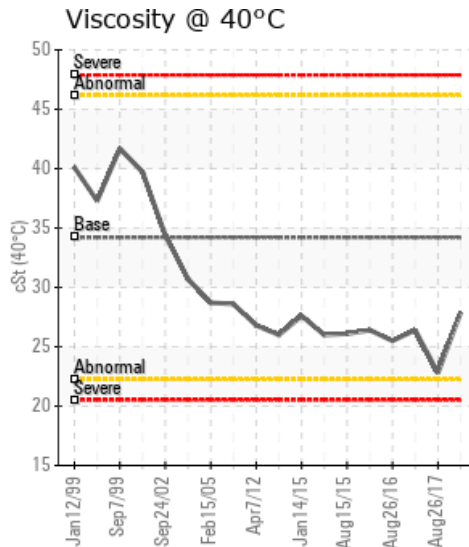
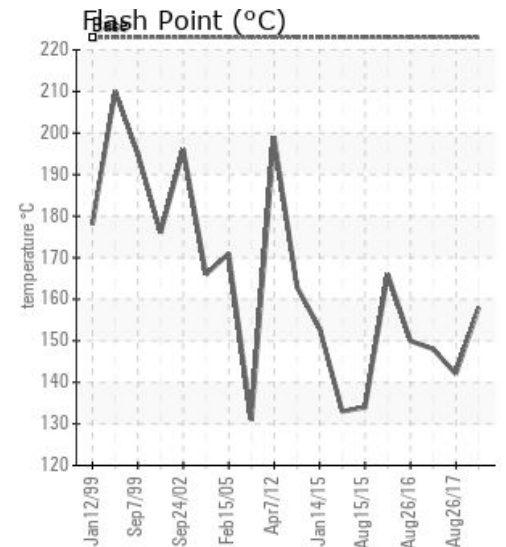
Comments: COC Flash Point is severely low. (GCD) % < 335°C is marginally high. (GCD) 10% Distillation Point is marginally low.

Recommendation: The current fluid has improved flash point, viscosity, and the distillation points. However, the fluid still has high content of the low boiler due to the thermal cracking at the 285 C bulk working temperature. Please continue to conduct the routine system venting and take one sample in 6 months to monitor the conditions.
