[13-25-80-16-W6M] H-5500-1 - Train 1

Customer: PTRHTF20156	System Information	Sample Information
TOURMALINE OIL 9920 98a Ave FORT ST. JOHN, BC V1J 1S2 Canada Attn: Brandon Braun Tel: (250)262-5420 E-Mail: Brandon.braun@tourmalineoil.com	System Volume: 40000 ltr Bulk Operating Temp: 464F / 240C Heating Source: Blanket: Fluid: PETRO CANADA PETRO-THERM Make: PROPAK	Lab No: 02237096 Analyst: Bill Quesnel CLS,OMA II,MLA-III,LLA-I Sample Date: 08/12/18 Received Date: 08/31/18 Completed: 08/12/20 Bill Quesnel CLS,OMA II,MLA-III,LLA-I

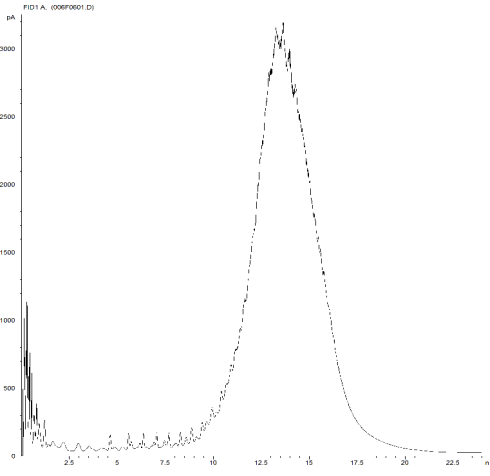
GCD Spectrum

Recommendation: Flash Point is severely low. Low flash point is a safety concern. % boil-off has increased to 6.27% from 2.42%. This may be attributed to either the condensate contamination and/or thermal degradation. This should be less than 1. Viscosity remains low; currently at 25 cSt vs 34 cSt of new fluid. Consider fluid replacement as the safest method to bring flash point back to acceptable values. Re-sample once fluid has been restored.
