RETURN CARGILL MEAT THAILAND

Customer: PTRHTF60010	System Information	Sample Information
SYNLUBE INTERNATIONAL CO LTD 76/1 MOO.7 THACHIN MUANG SAMUTSAKHON, 74000 THAILAND Attn: CHERNPORN CHOBKUI Tel: 034421290 E-Mail: chernporn@synlube.co.th	System Volume: 20910 ltr Bulk Operating Temp: 554F / 290C Heating Source: Blanket: Fluid: PETRO CANADA PURITY FG HEAT TRANSFER FLUID Make: WANSON	Lab No: 02237431 Analyst: Yutong Gao Sample Date: 08/25/18 Received Date: 09/05/18 Completed: 09/07/18 To discuss this report contact Yutong Gao at (403)873-1876

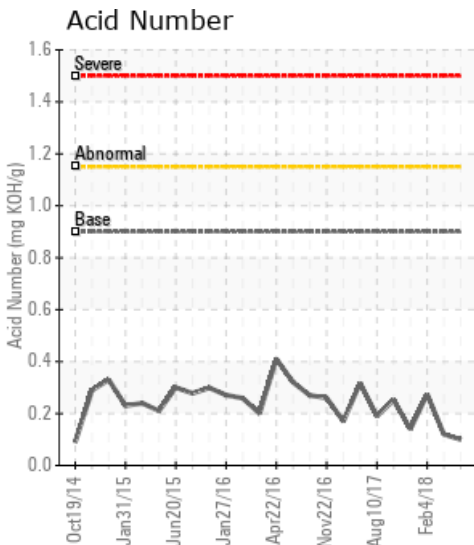
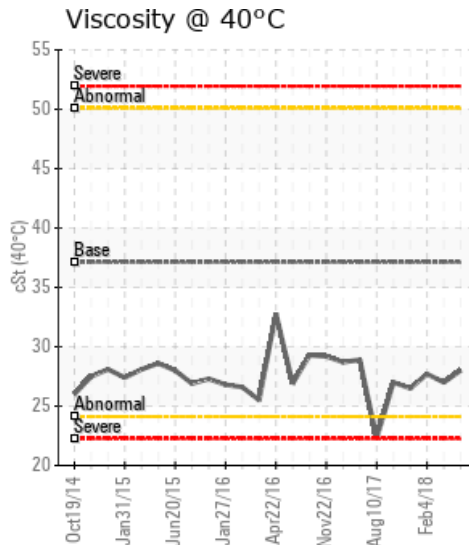
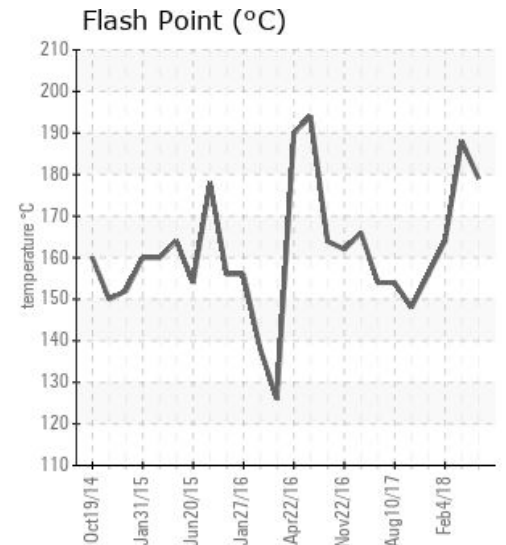
Recommendation: The current fluid conditions are very similar to the last sample in May. There are minimum third party contaminations such as water or dirty. The acid number and solid contents are very low, meaning minimum oxidation. The flash point is considered low due to thermal cracking at ~290C bulk working temperature. Please continue to do the system venting as a routine maintenance schedule. Please take one sample in 6 months to monitor the conditions.

Comments: COC Flash Point is abnormally low.
