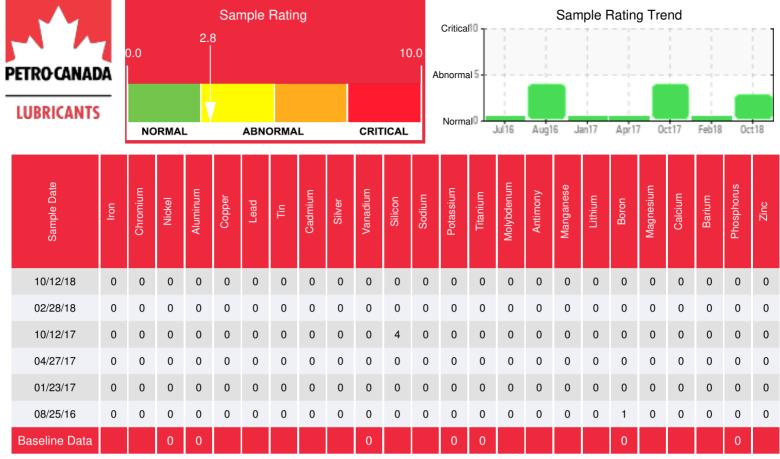
Comments: COC Flash Point is severely low. Acid Number (AN) is abnormally high.

Elemental anaysis results (above) in parts per million (ppm). [10,000 ppm = 1.0%]

Recommendation: It is understood that there was recently a condensate leak into the HTF system. This may explain the reduced flash point. A reduced flash point can be a safety concern. Following all safety protocol, venting of the low boiling vapors will help restore the flashpoint level to acceptable levels. Blanket gas cannot be in service during venting. Investigate if blanket gas pressure of 210 kpa is required for circulating pump suction head. If so, further investigation into venting is needed. Increased Acid Number generally is associated to oxidation of the fluid. Acid Number is at 0.35 yet iron remains at 0, so corrosion doesn't seem to be ongoing. Generally, sweetening is recommended around an Acid Number of 0.4. In this case, please plan to re-sample system in 6 months once all condensate has been safely removed and the Acid Number can be re-evaluated.
