RETURN CARGILL MEAT THAILAND

Customer: PTRHTF60010	System Information	Sample Information
SYNLUBE INTERNATIONAL CO LTD 76/1 MOO.7 THACHIN MUANG SAMUTSAKHON, 74000 THAILAND Attn: CHERNPORN CHOBKUI Tel: 034421290 E-Mail: chernporn@synlube.co.th	System Volume: 20910 ltr Bulk Operating Temp: 554F / 290C Heating Source: Blanket: Fluid: PETRO CANADA PURITY FG HEAT TRANSFER FLUID Make: WANSON	Lab No: 02253874 Analyst: Yutong Gao Sample Date: 11/17/18 Received Date: 11/27/18 Completed: 12/05/18

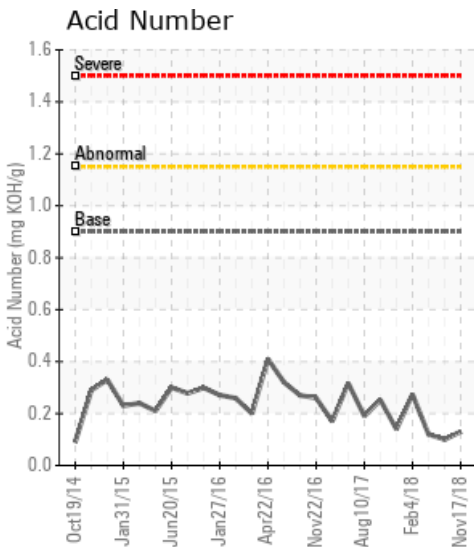
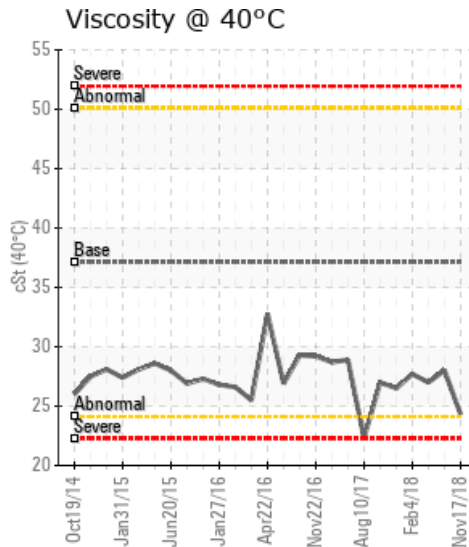
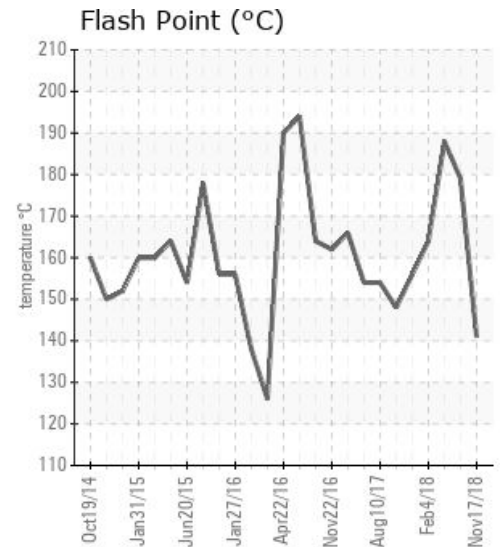
Comments: (GCD) 10% Distillation Point is severely low. (GCD) 90% Distillation Point is severely low. COC Flash Point is severely low. (GCD) % < 335°C is abnormally high. (GCD) 50% Distillation Point is abnormally low.

Sample Date	Received Date	Fluid Age	Sample Location	Flash Point (COC)	Water (KF)	Viscosity (40°C)	Acid Number	Solids	GCD 10%	GCD 50%	GCD 90%	GCD % < 335°C
	mm/dd/yy			°F/°C	ppm	cSt	mg/KOH/g	%wt	°F/°C	°F/°C	°F/°C	%
11/17/18	11/27/18	31m		286 / 141	10.9	24.3	0.13	0.022	603 / 317	731 / 388	823 / 439	14.48
08/25/18	09/05/18	28m	RETURN	354 / 179	7.2	28.0	0.10	0.022	674 / 356	800 / 427	897 / 481	6.22
05/23/18	06/12/18	25m	SUPPLY/RETURN	370 / 188	8.5	27.0	0.12	0.043	684 / 362	805 / 429	901 / 483	5.45
02/04/18	02/26/18	22m		327 / 164	0.00	27.7	0.274	0.022	685 / 363	787 / 419	868 / 464	3.98
11/01/17	11/14/17	19m		313 / 156	9.8	26.5	0.14	0.028	670 / 354	779 / 415	869 / 465	5.10
10/13/17	10/24/17	19m	RETURN	298 / 148	11.5	27.0	0.252	0.028	675 / 357	803 / 429	900 / 482	6.31
Baseline Data				459 / 237		37.12	0.90		721 / 383	807 / 431	892 / 478	1.5

Recommendation: The current fluid has low viscosity, low flash point due to the severe thermal cracking at high bulk working temperature. Please conduct the effective system venting to release the low boiler. The acid number and solid content are all very low indicating minimum oxidation and minimum system deposit. Please take one sample in 4 months to monitor the conditions.
