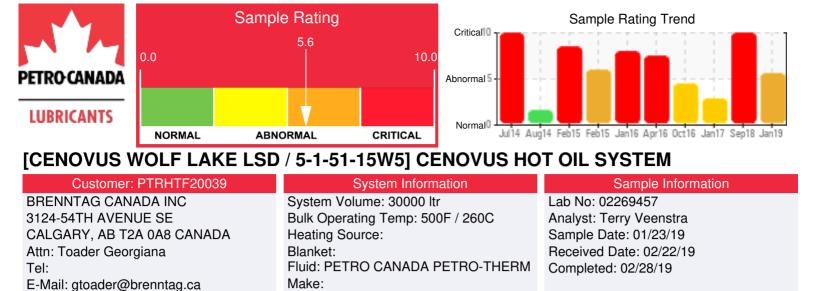
Comments: (GCD) 10% Distillation Point is severely low. COC Flash Point is severely low. (GCD) % < 335°C is marginally high.

Recommendation: GDC 10% Distillation as well has the Flash Point are low indicating some lighter ends. Venting of the system is required. Vent lighter ends off system and resample in 6 months.

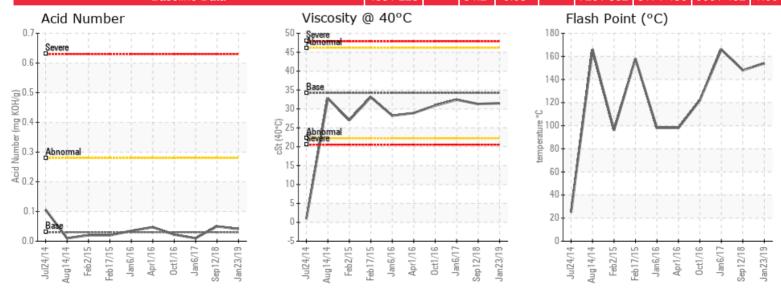
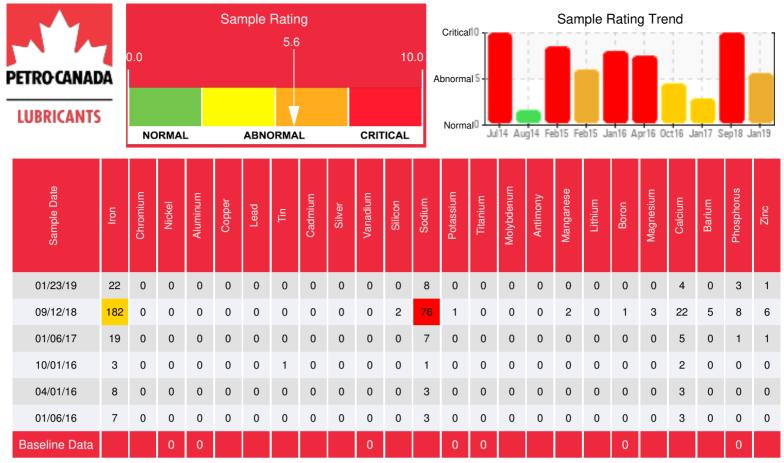
Elemental anaysis results (above) in parts per million (ppm). [10,000 ppm = 1.0%]
