TFS H/O SYSTEM #2

Customer: PTRHTF10176

CERTAINTEED ROOFING 100 CERTAINTEED DR JONESBURG, MO 63351 USA

Lab No: 02291773

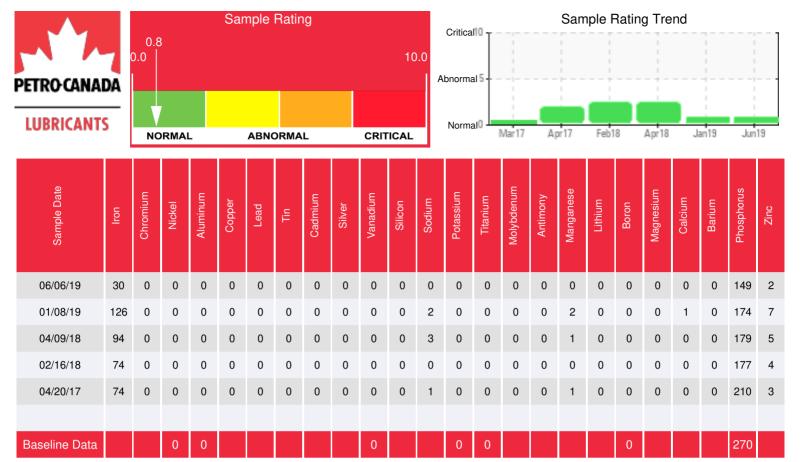
Comments: COC Flash Point is abnormally low.

Elemental analysis results (above) in parts per million (ppm). [10,000 ppm = 1.0%]

Recommendation: The viscosity has been slowly declining and so is the flash point. We suggest to vent the low boilers and replace the volume lost by adding fresh oil in the expansion tank.
