## **WANSON EPC 2500 ES**

## Customer: PTRHTF40020

LE DUC FINE FOOD BV MEESTER SNIJDERWEG 18

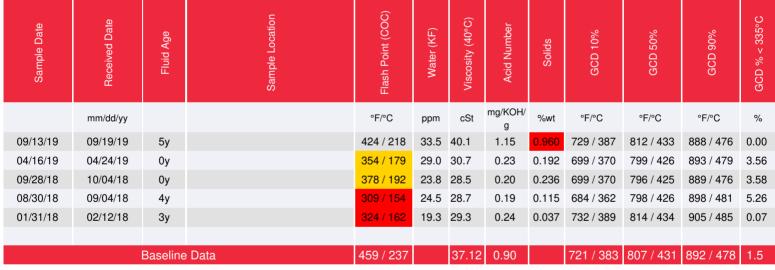
Comments: Pentane Insolubles levels are severely high.

Recommendation: Was this an oil change? All parameters around Flash Point and viscosity seem to have recovered to normal levels, but the insoluble are very high. Try some filtration to remove insoluble matter and check at normal oil sample interval.

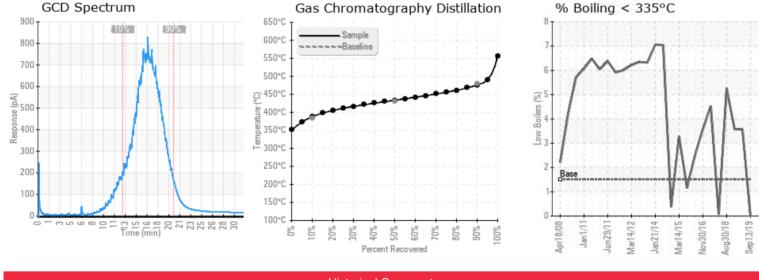
Historical Comments	
04/16/19	COC Flash Point trending downwards, and must show caution. If it can be recovered safely through any form of venting (although no great volume of light molecules look to be present) if would be worth doing to potentially extend the life of the fluid. Iron ppm levels are noted. COC Flash Point is abnormally low.
09/28/18	Looks to have been changed from previous sample. COC Flash Point already low and if safe to do so recommend venting system if possible to remove light molecules that have potentially brought flash point down. All other parameters within allowable limits. COC Flash Point is abnormally low.
08/30/18	COC Flash Point is very low indeed. Viscosity is trending slightly downwards also. Recommend the fluid is changed COC Flash Point is severely low.
01/31/18	COC Flash Point significantly lower than expected, confirming also previous result. Looking at the GCD the system has potentially been vented, there look to be fewer light end molecules. This has however had no impact on the COC Flash Point. All other parameters look to be improved from previous result. As this is a repeat result of the previous flash point, primary recommendation is for a system change out including a flush COC Flash Point is severely low.
