## LINE 3 HOT OIL SYSTEM

## Customer: PTRHTF10069

CERTAINTEED - SAINT GOBAIN 3303 EAST 4TH AVENUE SHAKOPEE, MN 55379 USA

Lab No: 02315483

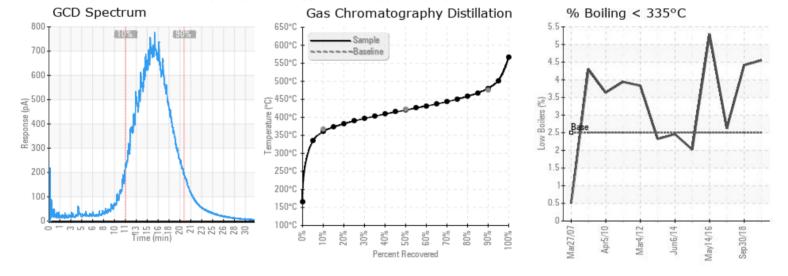
Baseline Data

Historical Comments	
09/30/18	This system has a history of having lower viscosity and what doesn't help is the flaws in the ASTM open cup flash point test is results jump up and down. So the viscosity is higher than on the last sample, yet the flash point is flagged for being lower. Overall you have managed this system well, just make sure the viscosity remains at least 23 cSt, but ideally we would like it to be a little higher. Since it seems to be more prone to thermal cracking, a slightly more frequent venting and replenishing might be needed on this system. COC Flash Point is abnormally low.
09/02/17	The viscosity remains low although the flash point and boiling properties remain normal. We suggest to maintain a certain venting schedule to prevent further reduction in viscosity and decrease in flash point. Remember to replace light ends vented off by adding fresh oil. Best practices suggest that the oil level in the expansion tank should be 75% full when in operation. Visc @ 40°C is abnormally low.

05/14/16	COC Flash Point is abnormally low. GCD IBP, 90% Distillation Point has decreased from the last sample. Pentane Insolubles have also increased and the phosphorus additive levels decreased markedly from the last sample. Resample next interval to monitor.
04/15/15	Sulfur levels are at 2112 ppm which is substantially higher than new oil values of <1 ppm. Investigate source of contamination. Viscosity at 40C is 23.3 cSt which is at >30% change condemning limit. Check for product used. Other properties are within normal ranges.
