WANSON EPC 2500 ES

Customer: PTRHTF40020	System Information	Sample Information
LE DUC FINE FOOD BV	System Volume: 1500 ltr	Lab No: 02328630
MEESTER SNIJDERWEG 18	Bulk Operating Temp: 265F / 129C	Analyst: Philip Riley
ZUID-HOLLAND	Heating Source:	Sample Date: 10/12/19
STELLENDAM, ZUI NETHERLANDS	Blanket:	Received Date: 12/23/19
Attn: Wilbert Snijers	Fluid: PETRO CANADA PURITY FG HEAT TRANSFER FLUID	Completed: 01/12/20
Tel:	Make: WANSON	
E-Mail: w.snijers@klt.nl

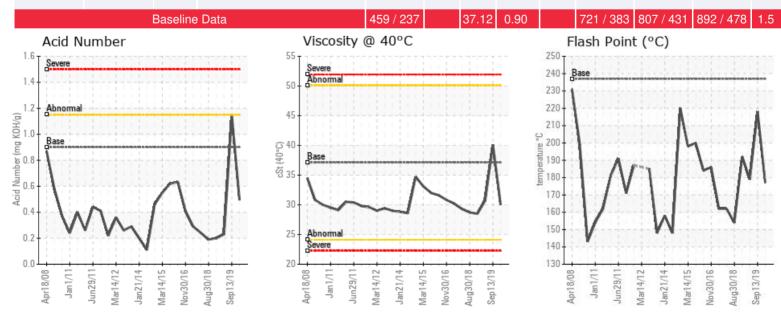
Recommendation: Going through the history of this sample it raises some concerns. In this current sample there has been a loss in viscosity of 10cSt from previous, and a significant drop in flash point to a level that is severely low. The curve shows a little evidence of cracking, but levels of low weight hydrocarbons look fairly low. SOme venting, if it can be done safely, may recover the flash point. I would attempt safe venting and re-sample. If it cannot be done a confirmation or another sample would be recommended as the step downwards in viscosity and flash point shows a worrying trend

Comments: COC Flash Point is severely low.

Historical Comments
09/13/19	Was this an oil change? All parameters around Flash Point and viscosity seem to have recovered to normal levels, but the insoluble are very high. Try some filtration to remove insoluble matter and check at normal oil sample interval. Pentane Insolubles levels are severely high.
	COC Flash Point trending downwards, and must show caution. If it can be recovered safely through any form of venting (although no great volume of light molecules look to be present) if would be worth doing to potentially extend the life of the fluid. Iron ppm levels are noted. COC Flash Point is abnormally low.
09/28/18	Looks to have been changed from previous sample. COC Flash Point already low and if safe to do so recommend venting system if possible to remove light molecules that have potentially brought flash point down. All other parameters within allowable limits. COC Flash Point is abnormally low.

08/30/18	COC Flash Point is very low indeed. Viscosity is trending slightly downwards also. Recommend the fluid is changed COC Flash Point is severely low.
