## RETURN CARGILL MEAT THAILAND

## System Information

Fluid: PETRO CANADA PURITY FG HEAT TRANSFER FLUID

## Sample Information

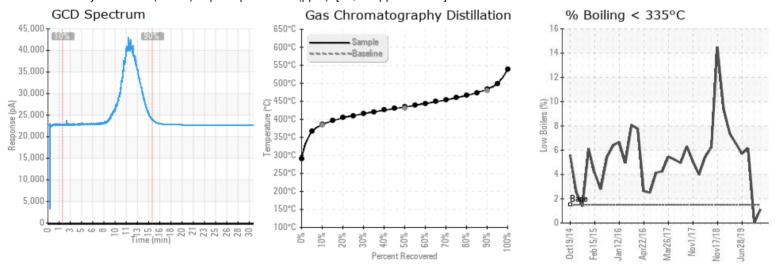
**Baseline Data**

Historical Comments	
01/14/20	Flash point (COC) slightly low but within reasonable boundaries. If safe venting can take place to recover then look towards this after next analysis if it continues to reduce but currently fit for further use. All other parameters meet spec. Please re-sample at normal interval COC Flash Point is marginally low.
10/12/19	COC very low and evidence of thermal cracking of the oil, with a history in this application. Viscosity has recovered slightly from last sample and COC Flash Pt is almost identical. Please look to further vent this system (if safe) and see if flash point can be recovered also. Distillation properties in line with expectation. Please sample following venting and check on recovery of the oil COC Flash Point is severely low.
06/28/19	The current fluid has normal distillation points. The acid number and solid content are all normal. The current fluid is suitable for operation. Please do the system venting as one of the routine maintenance activities to release the low boiler. Please take one sample in 6 months to monitor the conditions.

06/02/19	The current fluid condition is similar to the previous oil sample two months ago. The oil viscosity has been greatly improved. The oil distillation points are normal. The oil Acid Number and Solid contents are all low. However, the flash point is still severely low based on two repeated tests. Please conduct a long and effective system venting to release the light oil moisture to restore the higher flash point as soon as possible.
