SUPPLY CARGILL MEAT THAILAND

System Information

Fluid: PETRO CANADA PURITY FG HEAT TRANSFER FLUID

Lab No: 02348709 Analyst: Philip Riley Sample Date: 04/06/20 Received Date: 04/14/20 Completed: 04/26/20

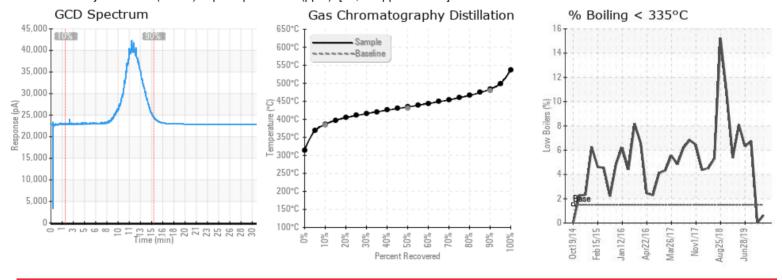
Historical Comments	
01/14/20	Oil tests to spec and all parameters as expected. Fit for further use and re-sample at normal frequency
10/12/19	Strong evidence of cracking indicated by the lowering viscosity and the low flash point. This looks to have been recovered in the past and if safe to do so the system must be vented. Distillation points remain mainly in line with fresh fluid. Please vent the system and take another sample to check how the system has recovered from removal of the light end molecules COC Flash Point is severely low. (GCD) 10% Distillation Point is marginally low.
06/28/19	The current fluid has normal distillation points. The acid number and solid content are all normal. The current fluid is suitable for operation. Please do the system venting as one of the routine maintenance activities to release the low boiler. Please take one sample in 6 months to monitor the conditions.

06/02/19	The current fluid conditions are slightly better than the previous oil sample two months ago. However, the flash point is still severely low considering the elevated low boiler generated by the thermal cracking? The oil Acid Number and Solid contents are all low. Please conduct a long and effective system venting to release the light oil moisture.

Recommendation: All parameters test to specification with the exception of the COC Flash Pt which is marginally low. The fluid remains suitable for operation, but recommend safe venting if possible to remove the low boiling point molecules. Please resample after normal frequency
