## LINE 1/2

Customer: PTRHTF60002	System Information	Sample Information
BOYNE SMELTERS LTD-RIO TINTO HANDLEY DRIVE QUEENSLAND BOYNE ISLAND, QUE 4680 AUSTRALIA Attn: Heath Mitchell Tel:	System Volume: 20000 ltr Bulk Operating Temp: 514F / 268C Heating Source: Blanket: Fluid: PETRO CANADA CALFLO AF Make:	Lab No: 02363208 Analyst: Philip Riley Sample Date: 03/31/20 Received Date: 07/07/20 Completed: 07/12/20 Philip Riley philip.riley@petrocanadalsp.com

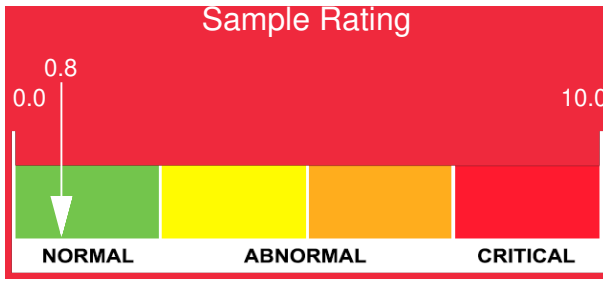
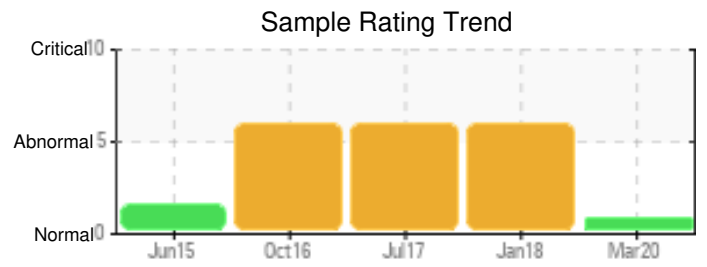
Recommendation: The Flash Pt has been recovered from previous samples, however remains in caution. The viscosity is very low indeed against the fresh oil. Looking at the GCD, the line shows a lot of peaks along the line, indicating thermal cracking. You must look to vent this system (safely) to remove the light end molecules. If a partial change has been done as per the last recommendation, it also indicates the fluid is heading towards end of life as the fluid seems to have a number of areas where it is deteriorating. Please conduct venting and send in another sample after 6 months max.

Comments: COC Flash Point is abnormally low.

Sample Date	Received Date	Fluid Age	Sample Location	Flash Point (COC)	Water (KF)	Viscosity (40°C)	Acid Number	Solids	GCD 10%	GCD 50%	GCD 90%	GCD % < 335°C
	mm/dd/yy			°F/°C	ppm	cSt	mg/KOH/g	%wt	°F/°C	°F/°C	°F/°C	%
03/31/20	07/07/20	20y	NEAR RETURN	334 / 168	15.3	21.4	0.04	0.062	652 / 345	788 / 420	893 / 479	7.99
01/10/18	01/23/18	10y		280 / 138	2.0	26.4	0.056	0.031	645 / 341	766 / 408	873 / 467	8.01
07/20/17	09/06/17	20y	NEAR RETURN TO GAS B	288 / 142	30.9	24.2	0.052	0.035	659 / 348	790 / 421	895 / 480	7.03
10/25/16	11/04/16	10y	NEAR RTRN TO GAS BRN	277 / 136	39.4	23.4	0.052	0.054	651 / 344	790 / 421	895 / 479	7.87
06/16/15	07/02/15	15y	LINE 1/2 AFTER PUMPS	295 / 146	25.2	23.9	0.12	0.017	661 / 349	792 / 422	901 / 483	6.70
Baseline Data				435 / 224		32.7	0.03		693 / 367	790 / 421	887 / 475	2.5

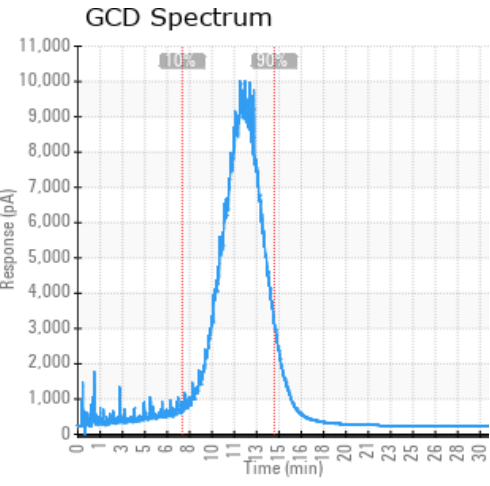
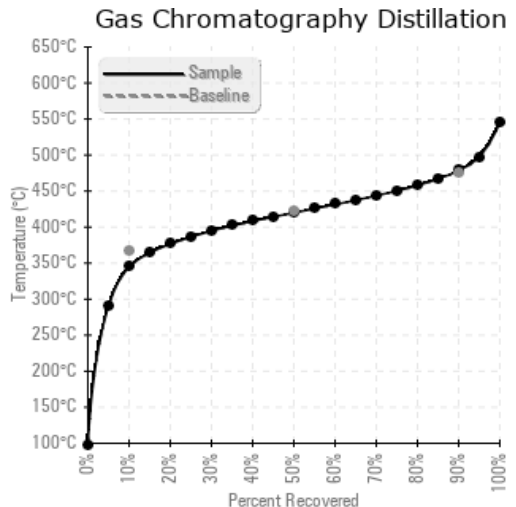
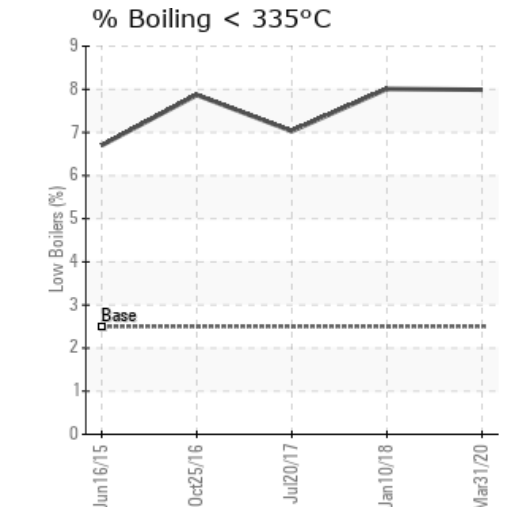
Historical Comments	
01/10/18	The current fluid has the similar conditions as the 2017 and 2016 samples. The fluid has been thermal cracked with some light boiler to reduce the flash point. Please conduct the effective system venting to release the oil vapor, or just do the 30% oil change to bring back the oil flash point and viscosity. Please take one sample in 6 months to monitor. COC Flash Point is severely low.
07/20/17	The fluid has a very similar condition as the sample in 2016. The fluid has normal acid number and solid content. However, the viscosity and flash point are all low because of the thermal cracking at 268C bulk working temperature. The effective system venting is required as soon as possible to release the light oil vapor. Please take one sample in one year to monitor the conditions.
10/25/16	The fluid flash point is severely low and the viscosity is abnormally low. The current fluid has a lot of low boiler (light end) due to the thermal cracking. The solid content, water ppm and TAN number are all normal. Please conduct the effective venting process as soon as possible to release the light end/oil vapor from the system. System venting is a recommended regular maintenance practice for any closed heat transfer system. If there is no way to vent the light end, please consider the complete fluid change or at least partial (i.e. 1/3 of the fluid) change to bring back the flash point and viscosity. Take one sample to verify the improvement after a longer and effective venting process or a partial fluid change.

06/16/15	The current fluid has a lot of low boiler (light end) due to the thermal cracking, therefore the flash point and the viscosity is much lower than the new fluid. The solid, water ppm and TAN number are all normal. Please conduct the effective venting process as soon as possible to release the light end/oil vapour from the system. System venting is a recommended regular maintenance practice for any closed heat transfer system. If there is no way to vent the light end, please consider the complete fluid change or at least partial (i.e. 1/3 of the fluid) change to bring back the flash point and viscosity. Take one sample to verify the improvement after a longer and effective venting or a partial fluid change. COC Flash Point is severely low. Viscosity is abnormally low.
