GFPT-FURTHER#3#4

Customer: PTRHTF60010	System Information	Sample Information
SYNLUBE INTERNATIONAL CO LTD	System Volume: 14350 ltr	Lab No: 02399579
76/1 MOO.7 THACHIN	Bulk Operating Temp: 554F / 290C	Analyst: Philip Riley
MUANG SAMUTSAKHON, 74000	Heating Source:	Sample Date: 01/11/21
THAILAND	Blanket:	Received Date: 01/25/21
Attn: CHERNPORN CHOBKUI	Fluid: PETRO CANADA PURITY FG HEAT TRANSFER FLUID	Completed: 01/28/21
Tel: 034421290	Make: HOVAL	Philip Riley
E-Mail: chernporn@synlube.co.th		philip.riley@petrocanadalsp.com

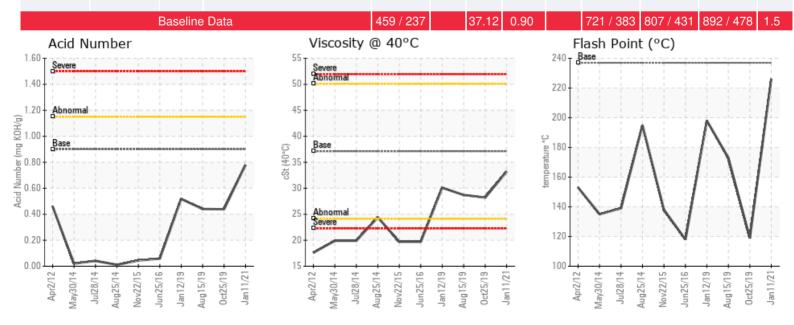
Comments: (GCD) 90% Distillation Point is abnormally high.

Historical Comments
10/25/19	Strong evidence of thermal cracking with the flash point at a severely low value. Must be vented to recover flash point otherwise look at immediate change of oil based on the severely low flash point COC Flash Point is severely low. (GCD) 10% Distillation Point is abnormally low. (GCD) % < 335°C is marginally high.
08/15/19	Historic results on this system show there have been much lower COC Flash Pt values, however, we cannot afford to work to these levels. Attempt to vent the system if safe to do so and remove light molecules to recover the flash point. If not please take a sample in 3 months to closely monitor and potentially look towards scheduling a change COC Flash Point is severely low. (GCD) 90% Distillation Point is abnormally high.
01/12/19	The current fluid has normal viscosity and flash point. The solid content and the water or dirt contaminants are all low. The fluid might experiences a mild oxidation due to the high bulk working temperature. Please make sure the expansion tank is sealed by the nitrogen blanket and the tank temperature is less than 65C during the normal operation. Please continue to run the oil and take one sample in 12 months to monitor the conditions.

06/25/16	(GCD) % < 335°C is severely high. COC Flash Point is severely low. The current fluid has been severely thermal cracked. The high content of light boiler causes the low flash point. The system venting is required, otherwise the oil change is required immediately.

Recommendation: All parameters within acceptable ranges. Please resample at normal frequency
