MAIN HOT OIL SYSTEM

Customer: PTRHTF10068

Certainteed - Saint Gobain 1077 PLEASANT ST

Lab No: 02401204 Analyst: Doug Vrooman Sample Date: 01/27/21 Received Date: 02/02/21 Completed: 02/05/21

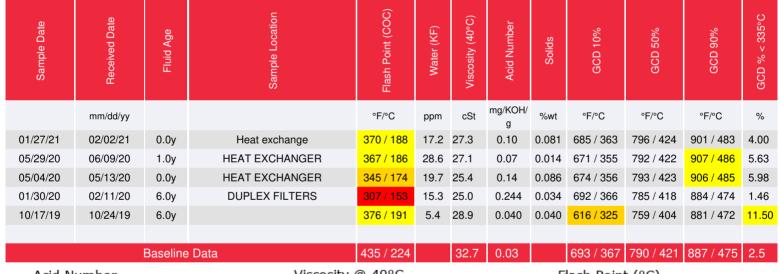
Recommendation: The Main Hot Oil System sample results show a slight increase in Flash Point - 186 to 188, however, Acid number had a slight increase also from .07 to .10. GCD at 10% remains good at 363.0 as well the GCD 90% at 482.5. No Vanadium was detected. Continue to monitor by sampling at a routine basis.

Comments: COC Flash Point is marginally low.

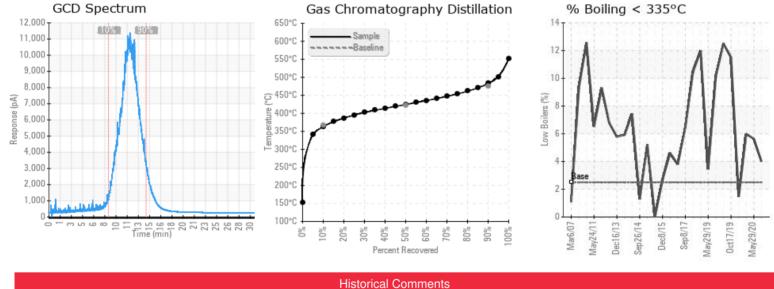
It appears the rented unit to strip off low boilers has helped bring the flash point and viscosity higher. This might help limp along for a while. let's keep monitoring every 6 months and re-evaluate the best way to maintain the fluid moving forward (sweetening or rent the unit). Many customers run with low oil levels in the expansion tank. If your expansion tank is <75% full when in operation, best practices suggest that it should be, so fresh oil could be added to keep with best practices but also to help maintain the oil properties. (GCD) 90% Distillation Point is marginally high. COC Flash Point is marginally high. COC Flash Point is how at 174 degrees. GCD 90% has risen to 485.4. Recommendations are consistent with the previous sample recommendation. Continue with the plan in place to remove low boilers and/or sweeten the system with fresh fluid. COC Flash Point is abnormally low. (GCD) 90% Distillation Point is marginally high. The oil condition has deteriorated but the flow issues with the pump have been resolved. Thermal cracking has occurred, reducing the viscosity and the flash point. Blends of in-service oil are being prepared with fresh Calflo AF to find the proper sweetening ratio. COC Flash Point is severely low. Although slightly different due to pulling samples in different locations, the last two samples - 10/17/2019 confirm the results of the sample on 9/20/2019. We would still recommend venting off the low boilers and/or add fresh fluid to the system to change the COC Flash Point and (GCD) %. (GCD) 10% Distillation Point is abnormally low. (GCD) % < 335°C is marginally high. COC Flash Point is marginally low.
