FILLER HEATER

Customer: PTRHTF10068

Certainteed - Saint Gobain 1077 PLEASANT ST NORWOOD, MA 02062 USA

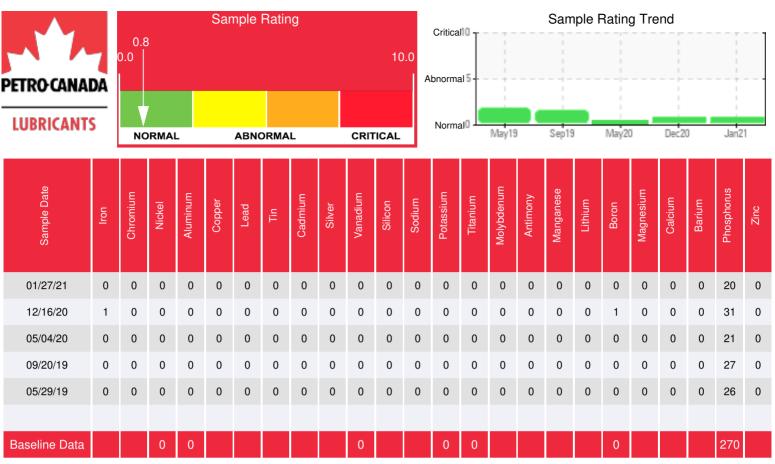
Recommendation: The sample results for the Filler Heater have shown slight improvements with Flash point from 188 to 190. Low boilers GCD 10% 363.4 have shown a slight increase whereas GCD 90% 483.7 have decrease slightly. Acid number has also increased from .05 to .09. Continue to monitor at planned intervals.

Comments: COC Flash Point is marginally low.

Elemental analysis results (above) in parts per million (ppm). [10,000 ppm = 1.0%]
