SOUTH HEATER

Customer: PTRHTF10043	System Information	Sample Information
MALARKY ROOFING PRODUCTS 3131 N. COLUMBIA BLVD PORTLAND, OR 97217 USA Attn: Jeff Tonn Tel: E-Mail: jtonn@malarkeyroofing.com	System Volume: 1200 gal Bulk Operating Temp: 620F / 327C Heating Source: Blanket: Fluid: PETRO CANADA CALFLO HTF Make: AMERICAN HEATING	Lab No: 02404157 Analyst: Ron LeBlanc Sample Date: 01/28/21 Received Date: 02/17/21 Completed: 02/22/21 Ron LeBlanc Ronald.LeBlancSr@hollyfrontier.com

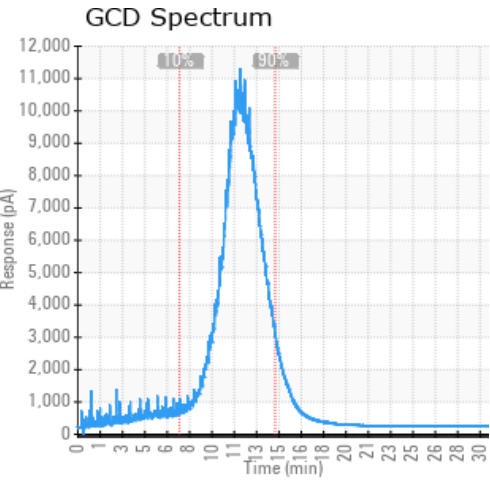
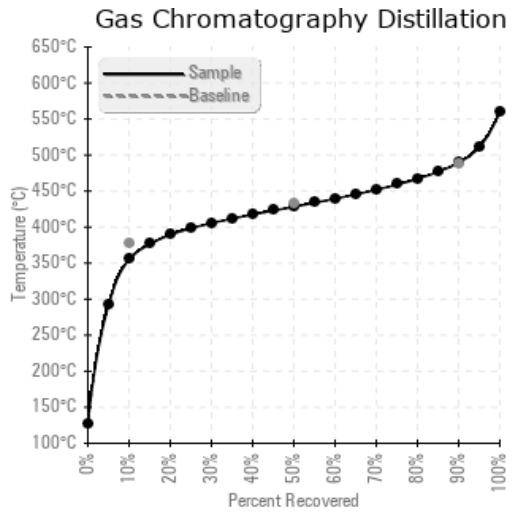
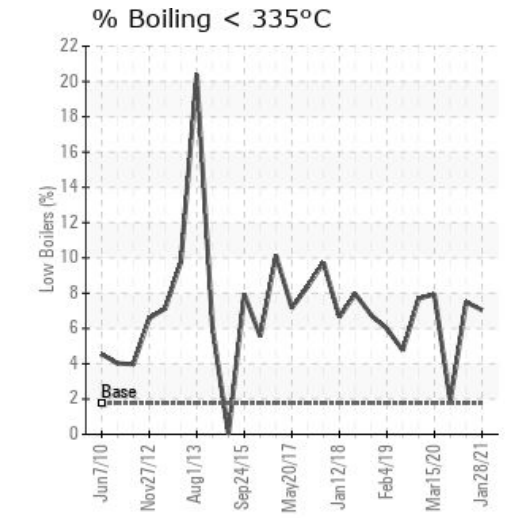
Comments: COC Flash Point is severely low.

Historical Comments	
07/10/20	COC Flash point is low which indicates thermal degradation or possible contamination. Be sure the sample port was purged sufficiently before capturing sample oil. COC Flash Point is severely low.
03/18/20	The COC flash point is low again compared to the previous sample. All other typicals remain normal. Could the reported sample have been pulled without proper purging? Adding some new oil would bring up the flash point. Resample in 30 days and purge at least 2 gallons from sample point to evaluate the results. COC Flash Point is severely low.
03/15/20	COC Flash Point is very low. A low flash point can indicate thermal degradation. Add new oil to bring up Flash Point. (GCD) % < 335°C is marginally high. Make sure the oil was purged before collection into the sample container to get the best sample. COC Flash Point is severely low. (GCD) % < 335°C is marginally high.

08/09/19	COC Flash point came up from the previous sample. (GCD) 90% point is marginally low. Resample in 3 months. COC Flash Point is marginally low. (GCD) 90% Distillation Point is marginally low.

Recommendation: (GCD) 10% is low which can cause the flash point to lower significantly indicating low boilers. The low boilers can be removed via the expansion tank. Re-sample in 6 months.
