## LINE 1/2

Customer: PTRHTF60002	System Information	Sample Information
BOYNE SMELTERS LTD-RIO TINTO HANDLEY DRIVE QUEENSLAND BOYNE ISLAND, QUE 4680 AUSTRALIA Attn: Heath Mitchell Tel:	System Volume: 20000 ltr Bulk Operating Temp: 514F / 268C Heating Source: Blanket: Fluid: PETRO CANADA CALFLO AF Make:	Lab No: 02460672 Analyst: Philip Riley Sample Date: 11/24/21 Received Date: 12/07/21 Completed: 12/13/21 Philip Riley philip.riley@hollyfrontier.com

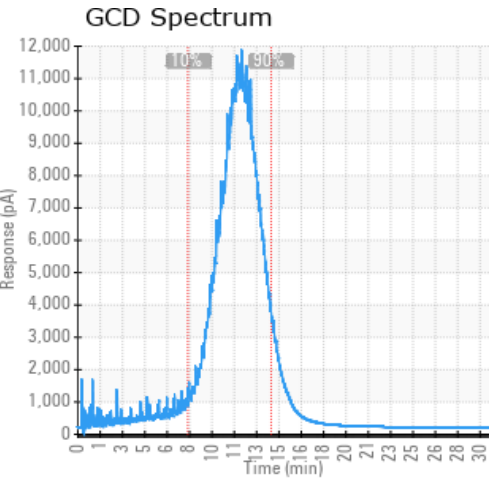
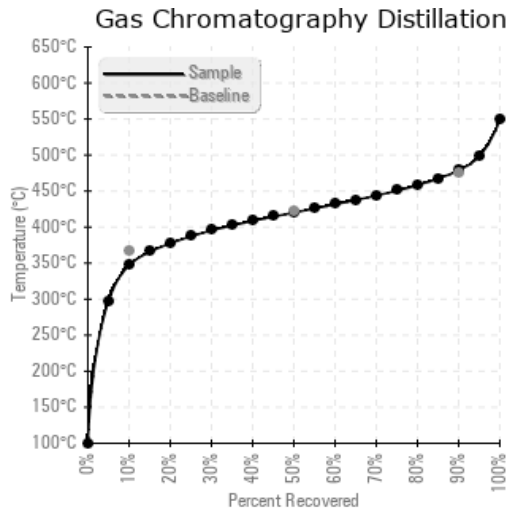
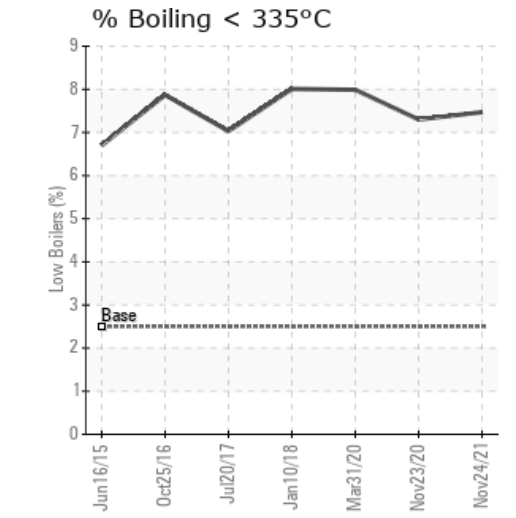
Recommendation: COC Flash Point is low, but improved from the previous sample. Again, there is viscosity drop, and in line with the GCD curve, evidence of fluid cracking (when you link viscosity drop, low flash point, graph). If the system can be safely vented then there is the possibility to recover the flash point and remove the light ends. Conscious this system was changed within the last 12 months, and the results on Line 3 are distinctly different, where the fluid is in very good condition. After venting (if possible), would be interesting to see another sample to see if and how the fluid has recovered somewhat

Comments: COC Flash Point is marginally low.

Historical Comments	
11/23/20	COC Flash Point is very low and in line with the viscosity drop showing evidence of thermal cracking of the fluid. This is further supported by the GCD curve which shows clear cracking of the fluid. If the system can be safely vented then there is the possibility to recover the flash point and remove the light ends. If it cannot be safely vented then you need to look towards a potential oil change with clean and flush. The fluid will only deteriorate further without action. The flash point has been lower and recovered and the insolubles and acid number remain low. COC Flash Point is abnormally low.
03/31/20	The Flash Pt has been recovered from previous samples, however remains in caution. The viscosity is very low indeed against the fresh oil. Looking at the GCD, the line shows a lot of peaks along the line, indicating thermal cracking. You must look to vent this system (safely) to remove the light end molecules. If a partial change has been done as per the last recommendation, it also indicates the fluid is heading towards end of life as the fluid seems to have a number of areas where it is deteriorating. Please conduct venting and send in another sample after 6 months max. COC Flash Point is abnormally low.

01/10/18	The current fluid has the similar conditions as the 2017 and 2016 samples. The fluid has been thermal cracked with some light boiler to reduce the flash point. Please conduct the effective system venting to release the oil vapor, or just do the 30% oil change to bring back the oil flash point and viscosity. Please take one sample in 6 months to monitor. COC Flash Point is severely low.
07/20/17	The fluid has a very similar condition as the sample in 2016. The fluid has normal acid number and solid content. However, the viscosity and flash point are all low because of the thermal cracking at 268C bulk working temperature. The effective system venting is required as soon as possible to release the light oil vapor. Please take one sample in one year to monitor the conditions.
