Customer: PTRHTF20171	System Information	Sample Information
Keyera Energy - Nordegg River Gas P	System Volume: 42000 ltr	Lab No: 02464406
06-10-044-12w5	Bulk Operating Temp: 356F / 180C	Analyst: Lyle Dach
Nordegg, AB T0M 2H0 Canada	Heating Source:	Sample Date: 12/13/21
Attn: Todd Kjorlien	Blanket:	Received Date: 12/30/21
Tel: (780)514-8988	Fluid: PETRO CANADA PETRO-THERM	Completed: 01/07/22
E-Mail: todd_kjorlien@keyera.com	Make: STEARNS-ROGERS	Lyle Dach
		lyle.dach@hollyfrontier.com

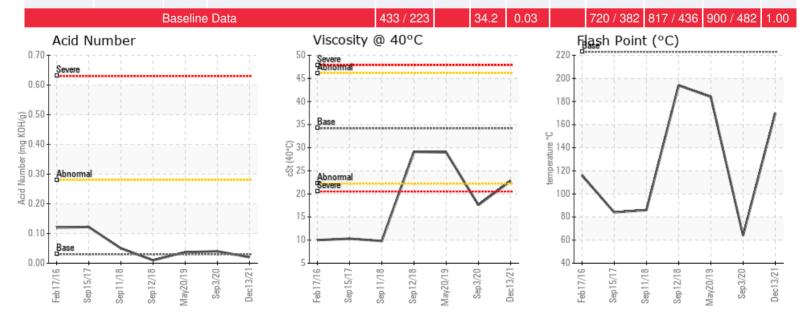
Recommendation: Fluid has improved from last sample but fluids viscosity is still low, GCD%<335°C is on the high side, 10% distillation temperature is low and flash point is also low. Fluid is seeing some thermal degradation or could be contaminated by process fluid. Lower boilers (light ends) should be vented off at the expansion tank. If possible confirm the Petro-Therm has not been contaminated with process products. Resample in 6 months to ensure venting is helping improve fluid quality.

09/03/20	Very low viscosity & flash point are caused either by thermal cracking or possibly process exchanger leaking condensate into HT fluid. If thermal cracking is the cause there will be carbonaceous deposit in the system as a result. Contact PC Tech Services to discuss remedial action. Viscosity and flash point extremely low
05/20/19	Fluid condition generally very good overall. Viscosity & Flash Point are a little low, likely from previous residuals. Essentially no significant change from the previous sample Sept 2018. GCD 90% is just into the abnormal range
09/12/18	Fluid is in excellent condition. The only concern is the water content which is a little higher than expected. Suggest annual sample submissions - sooner if fluid gets exposed to severe conditions or contamination is suspected. Water contamination levels are marginally high.
09/11/18	Severely low flash point & viscosity from suspected contamination. Very little change from the previous sample September 2017. As I understand it this fluid has been replaced which is good. (GCD) 10% Distillation Point is severely low. COC Flash Point and visc @ 40°c are severely low. Calcium ppm levels are abnormally high. (GCD) 90% Distillation Point is marginally low.
