## TFS H/O SYSTEM #2

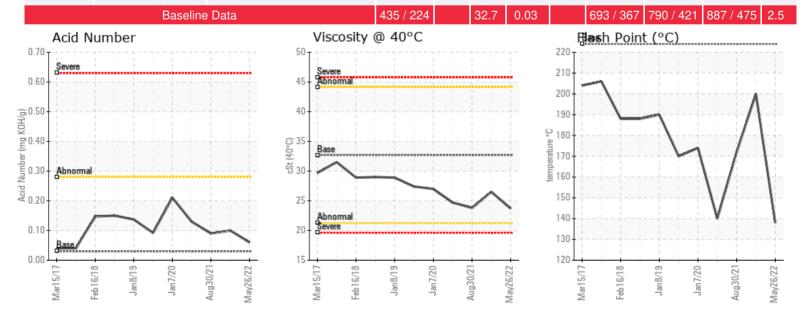
Recommendation: Flash Point is severely low and GCD shows the formation of some light boilers. Other properties are acceptable.

Comments: COC Flash Point is severely low.
