WANSON BH/INC 1200

Customer: PTRHTF40127

Dalco Foods B.V Everdenberg 50

Lab No: 02501988 Analyst: Kevin Marson Sample Date: 07/20/22 Received Date: 07/26/22 Completed: 08/03/22

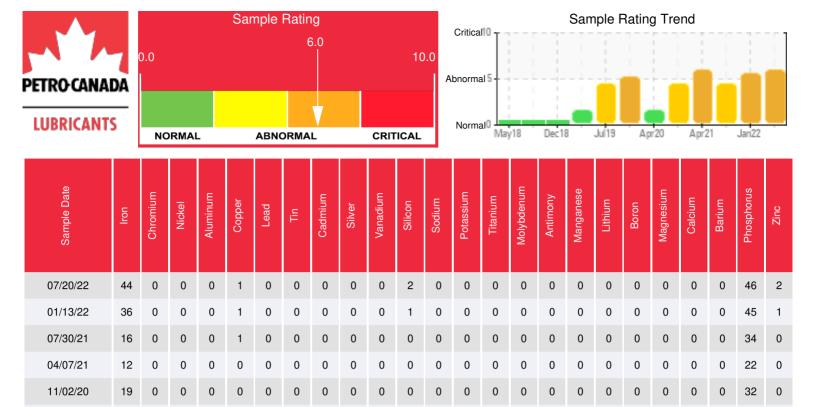
Comments: COC Flash Point is severely low. (GCD) 10% Distillation Point is abnormally low. (GCD) % < 335°C is marginally high.

Elemental analysis results (above) in parts per million (ppm). [10,000 ppm = 1.0%]

Recommendation: Flash Point (COC) is very low and off specification. Recommend venting the system in order to reduce number of low boilers and recover flash point. Recommend resampling in six months to monitor.

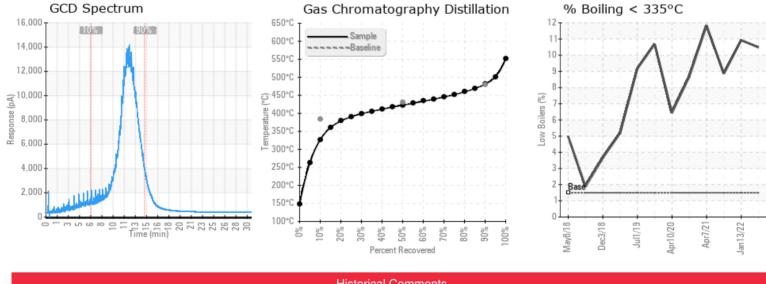
Baseline Data

Historical Comments	
01/13/22	Flash Point (COC) is very low and off specification. Recommend venting the system in order to reduce number of low boilers and recover flash point. Recommend resampling in six months to monitor. COC Flash Point is severely low. (GCD) 10% Distillation Point is abnormally low. (GCD) % < 335°C is marginally high.
07/30/21	Flash Point (COC) is very low and off specification. Recommend venting the system in order to reduce number of low boilers and recover flash point. COC Flash Point is severely low. (GCD) 10% Distillation Point is abnormally low. (GCD) % < 335°C is marginally high.
04/07/21	Flash Point continues to be very low. Viscosity has decreased and evidence of cracking of the oil. Viscosity reduction is consistent and the value is distant from what we expect to see, it supports the theory of lower viscosity molecules being produced. Please try safe venting and check for recovery. Several warnings now on flash point and if recovery attempts have failed, recommend to look towards change. (GCD) 10% Distillation Point is severely low. COC Flash Point is severely low. (GCD) % < 335°C is abnormally high. Visc @ 40°C is abnormally low.

11/02/20	Flash Point (COC) is very low and off specification. Recommend venting the system in order to reduce number of low boilers and recover flash point. COC Flash Point is severely low. (GCD) % < 335°C is marginally high. (GCD) 10% Distillation Point is marginally low.
