TFS H/O SYSTEM #2

Customer: PTRHTF10176	System Information	Sample Information
CERTAINTEED ROOFING	System Volume: 4244 gal	Lab No: 02501991
100 CERTAINTEED DR	Bulk Operating Temp: 525F / 274C	Analyst: Neil Buchanan
JONESBURG, MO 63351 US	Heating Source:	Sample Date: 07/15/22
Attn: Jeff Montgomery	Blanket:	Received Date: 07/26/22
Tel: (952)261-9532	Fluid: PETRO CANADA CALFLO AF	Completed: 07/27/22
E-Mail: jeffrey.d.montgomery@saint-	Make: FSE	Neil Buchanan
gobain.com		neil.buchanan@HFSinclair.com

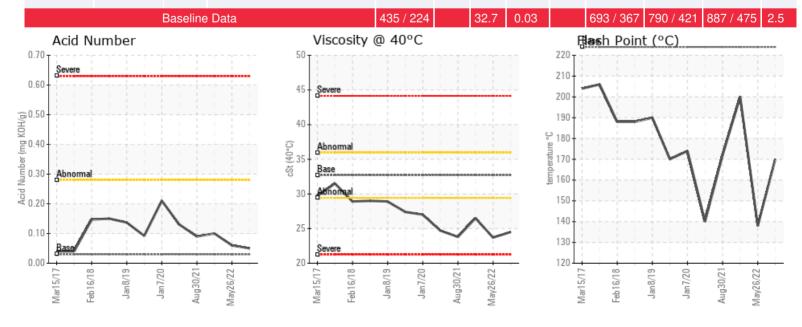
Recommendation: Flash Point is very low and GCD % <335C is elevated showing the formation of low boilers.

Comments: COC Flash Point is abnormally low. Visc @ 40°C is abnormally low.
