## LINE 1

## Customer: PTRHTF10164

Fluid: PETRO CANADA CALFLO HTF

Lab No: 02541173 Analyst: Garrett Bapp Sample Date: 01/03/23 Received Date: 02/23/23 Completed: 03/10/23

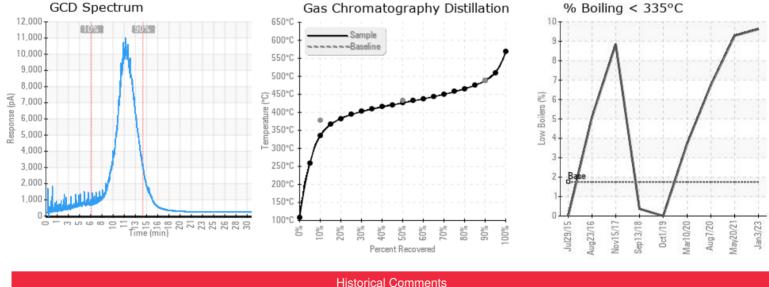
Historical Comments	
05/20/21	Thermal degradation of the fluid represented by GCD %<335°C, lower than normal COC Flash Point and Low GCD 10%. All other parameters are on spec. Recommended to vent light ends from the system and sweeten with 20% fluid volume. (GCD) 10% Distillation Point is abnormally low. (GCD) % < 335°C is marginally high. COC Flash Point is marginally low.
08/07/20	Fluid continues to show signs of thermal cracking but is suited for continued use. Recommend to vent light ends from system and sample at next interval. COC Flash Point is abnormally low.
03/10/20	System is in good health. Fluid continues to show signs of thermal degradation. COC Flash Point of 170°C is 61°C below new. All other parameters are within targets. Recommend venting of low boilers from the expansion tank. COC Flash Point is severely low.
10/01/19	Fluid is suitable for continued use. There is evidence of oxidation and thermal cracking. Acid number is rising. Viscosity is slightly reduced but still within viscosity grade. Flash point is 36°C lower than specified for new fluid. (GCD) 90% Distillation Point is slightly elevated. Pentane Insolubles has increased from previous sample. To increase the longevity of fluid, vent low boilers and a 20% drain and refill during the next system shutdown should help. Continue monitoring and yearly sampling. System wear in good health. System contaminants in good health. (GCD) 90% Distillation Point is marginally high. COC Flash Point is marginally low.
