LINE 1/2

Customer: PTRHTF60002	System Information	Sample Information
BOYNE SMELTERS LTD-RIO TINTO HANDLEY DRIVE QUEENSLAND BOYNE ISLAND, QUE 4680 AUSTRALIA Attn: Heath Mitchell Tel:	System Volume: 20000 ltr Bulk Operating Temp: 514F / 268C Heating Source: Blanket: Fluid: PETRO CANADA CALFLO AF Make:	Lab No: 02561482 Analyst: Philip Riley Sample Date: 03/13/23 Received Date: 06/02/23 Completed: 06/25/23 Philip Riley philip.riley@HFSinclair.com

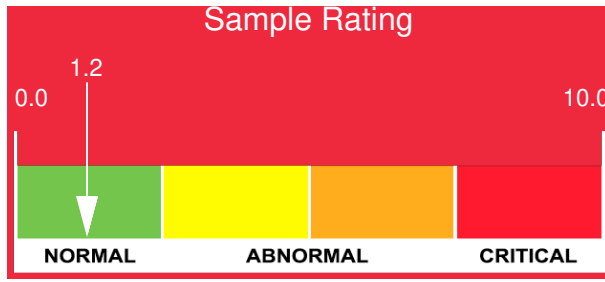
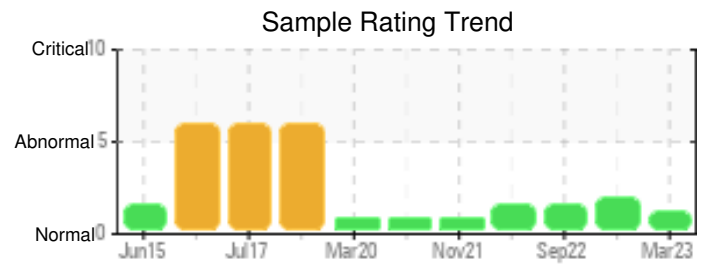
Recommendation: Fluid recovered slightly from partial change (?) previously. Viscosity tracking down, along with flash point which shows continued thermal stress to the fluid. Please resample at normal frequency and as I believe a change is scheduled, there may be degradation at a slightly higher rate as some residual fluid remains following sweetening.

Comments: Visc @ 40°C is abnormally low. COC Flash Point is marginally low.

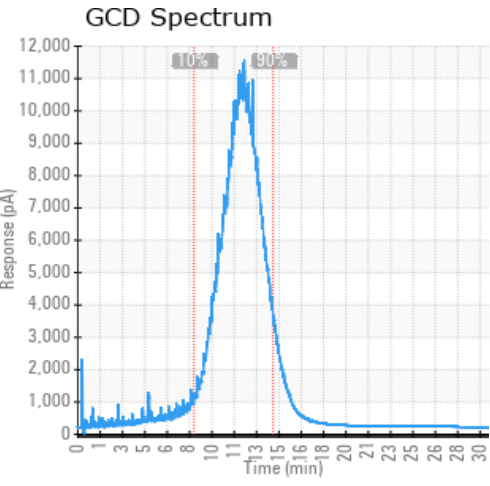
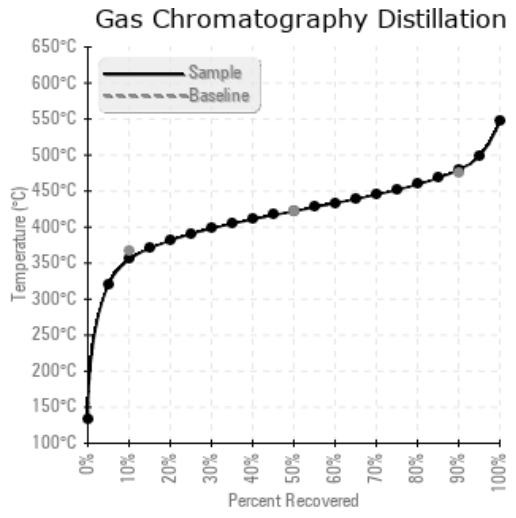
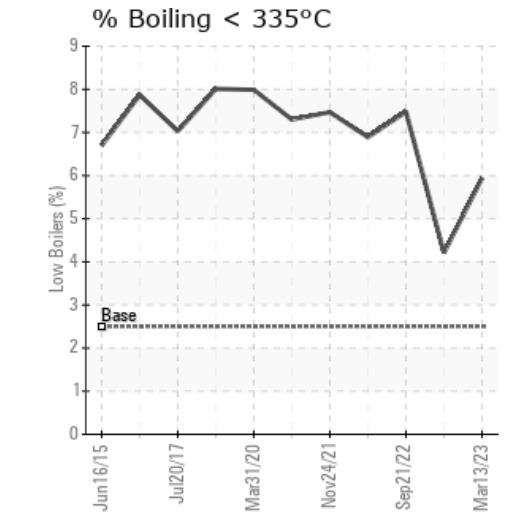
Historical Comments	
01/19/23	Partial change recovered the flash point as expected, but this is a temporary measure to get to a safe place. There is a lot of sediment in the system and the visco is running low, evidence of cracking and whilst the low boiling point molecules are removed by venting, the other forms of degradation stay behind and will affect the oil. You have pushed back the urgency and should plan a change out in the coming months, including a clean and flush of the system. Pentane Insolubles levels are severely high. Visc @ 40°C is abnormally low.
09/21/22	As per recent discussions, confirms the low flash point and you are doing the right thing on site by a partial change to increase this flash point and work in a safer zone. Change including a clean and flush should be planned for convenient point in coming months. I would resample a day after the partial change is done so you can get a new baseline. COC Flash Point is severely low.

05/27/22	Fluid needs attention based on Flash Point at 154C. Unless the flash point can be recovered you need to look to change out this system. Viscosity has also dropped, supporting some form of increase in light molecules. Recommend venting if can be done safely and, allowing the system to settle and re-sampling to see if there has been flash point recovery. If there is little in the way of recovery then you need to work to change this oil based on the flash point. COC Flash Point is severely low.
11/24/21	COC Flash Point is low, but improved from the previous sample. Again, there is viscosity drop, and in line with the GCD curve, evidence of fluid cracking (when you link viscosity drop, low flash point, graph). If the system can be safely vented then there is the possibility to recover the flash point and remove the light ends. Conscious this system was changed within the last 12 months, and the results on Line 3 are distinctly different, where the fluid is in very good condition. After venting (if possible), would be interesting to see another sample to see if and how the fluid has recovered somewhat. COC Flash Point is marginally low.
