[6-10-44-12W5] HEAT TRANSFER

Customer: PTRHTF20171

$\label{eq:continuous_problem} \mbox{Keyera Energy - Nordegg River Gas P...}$

06-10-044-12w5

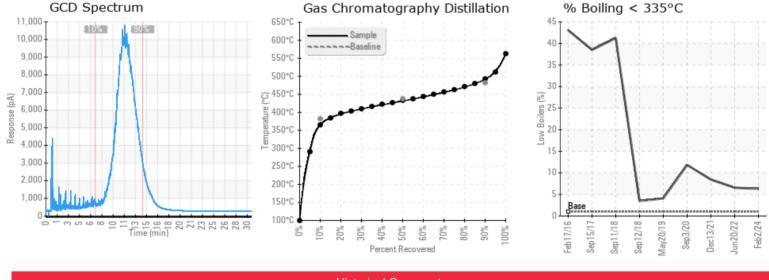
Comments: Visc @ 40°C is abnormally low. COC Flash Point is marginally low.

Historical Comments	
06/20/22	Fluid condition has improved from the last sample and overall is in good condition. If venting low boilers has been done this has helped improve fluid condition. Continue current venting practice to attempt to increase viscosity and COC flash point while continuing to lower GCD %<335C. Resample in 6 months. COC Flash Point is abnormally low.
12/13/21	Fluid has improved from last sample but fluids viscosity is still low, GCD%<335°C is on the high side, 10% distillation temperature is low and flash point is also low. Fluid is seeing some thermal degradation or could be contaminated by process fluid. Lower boilers (light ends) should be vented off at the expansion tank. If possible confirm the Petro-Therm has not been contaminated with process products. Resample in 6 months to ensure venting is helping improve fluid quality.
09/03/20	Very low viscosity & flash point are caused either by thermal cracking or possibly process exchanger leaking condensate into HT fluid. If thermal cracking is the cause there will be carbonaceous deposit in the system as a result. Contact PC Tech Services to discuss remedial action. Viscosity and flash point extremely low

05/20/19	Fluid condition generally very good overall. Viscosity & Flash Point are a little low, likely from previous residuals. Essentially no significant change from the previous sample Sept 2018. GCD 90% is just into the abnormal range

Recommendation: Viscosity has dropped slightly from last sample but flash point is continuing to improve. If venting is being done to reduce low boilers it has been helping to improve fluid condition. Continue current venting practice to attempt to increase viscosity and COC flash point while continuing to lower GCD %<335C. High blanket pressure can allow fuel gas be entrained in the fluid and cause a reduction in viscosity and flash point. Petro Canada Lubricants recommends blanket gas pressure of 2-3 PSI if pump NPSH is not artificially increased by high blanket gas pressure. Resample in 6 months.
