UNIT A

Customer: PTRHTF30035	System Information	Sample Information
VEOLIA WATER 9 LESLIE STREET TORONTO, ON M4M 3M9 CA Attn: MICHAEL VULJICIC Tel: (416)996-2340 E-Mail: michael.vujcic@veolia.COM	System Volume: 6000 ltr Bulk Operating Temp: 280F / 138C Heating Source: Blanket: Fluid: PETRO CANADA CALFLO HTF Make:	Lab No: 02623559 Analyst: Behshad Sabah Sample Date: 03/15/24 Received Date: 03/20/24 Completed: 03/25/24 Behshad Sabah behshad.sabah@HFSinclair.com

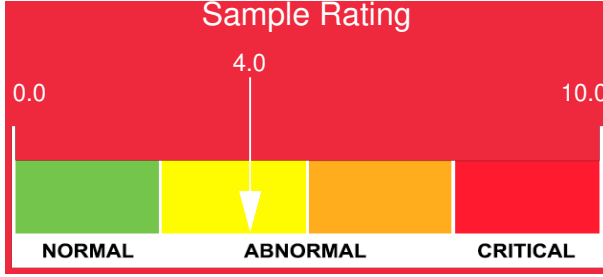
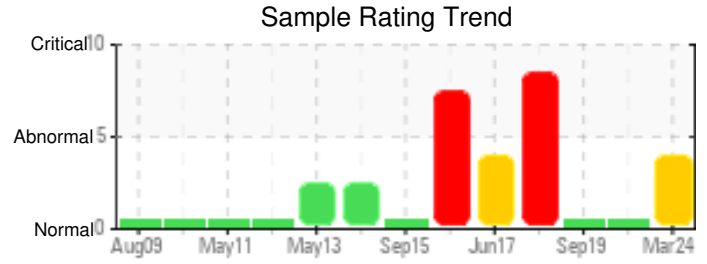
Recommendation: the test results show an abnormal spike on the sulfur ppm of the oil which can be a product contamination by added wrong oil. the wrong oil - may be gear oil- has been cracked and dropped the overall mix viscosity and a significant drop on the flash point. you cannot filter the wrong oil out, but you need to 'sweeten' the system. drain 10% to 20% of the volume and top up with fresh Clafo HTF before it gets too late. the wrong oil oxidation will increase the pentane insoluble percentage to the point that you need to drain, clean, and flush the system. at this moment no chemical corrosion is detected in the system. there is low risk of pinholes and leak.

Comments: COC Flash Point is severely low. Visc @ 40°C is abnormally low. (GCD) % < 335°C is marginally high.
