WANSON BH/INC 1200

Customer: PTRHTF40127	System Information	Sample Information
Dalco Foods B.V	System Volume: 4200 gal	Lab No: 02624515
Everdenberg 50	Bulk Operating Temp: 518F / 270C	Analyst: Bill Quesnel CLS,OMA II,MLA-
Oosterhout, 4902TT NL	Heating Source:	III,LLA-I
Attn: Wilbert Snijers	Blanket:	Sample Date: 03/19/24
Tel:	Fluid: PETRO CANADA PURITY FG HEAT TRANSFER FLUID	Received Date: 03/25/24
E-Mail: w.snijers@klt.nl	Make: WANSON	Completed: 04/08/24
		Bill Quesnel CLS,OMA II,MLA-III,LLA-I

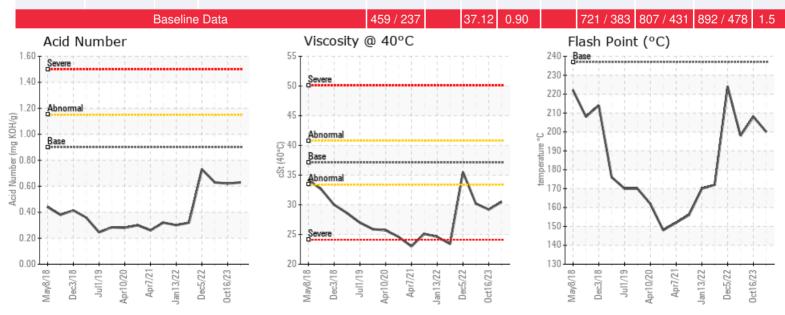
Comments: COC Flash Point is marginally low.

Historical Comments			
10/16/23	The flash point has increased. The fluid is suitable for further service. Resample at the next service interval to monitor.		
05/31/23	We recommend that you vent the expansion tank to remove low boilers which assists in restoring the flash point of the fluid. The fluid is suitable for further service. Resample at the next service interval to monitor. COC Flash Point is marginally low.		
12/05/22	If expansion tank venting was carried out, this has successfully restored the flash point of the fluid. Vent expansion tank every three months to remove light ends from the fluid. Fluid is suitable for continued use. Resample at next normal interval to monitor.		
07/20/22	Flash Point (COC) is very low and off specification. Recommend venting the system in order to reduce number of low boilers and recover flash point. Recommend resampling in six months to monitor. COC Flash Point is severely low. (GCD) 10% Distillation Point is abnormally low. (GCD) % < 335°C is marginally high.

Recommendation: We recommend that you vent the expansion tank to remove low boilers which assists in restoring the flash point of the fluid. The fluid is suitable for further service. Resample at the next service interval to monitor.
