PROBLEM SUMMARY

Area
[98272424]
 Machine Id
KR-GR-001552-SOUTH - 15000 LB MIXER (S/N MIX A - 11513053)
 Component
Gearbox
 Fluid
PETRO CANADA 220 (13 GAL)

OIL ANALYSIS REPORT

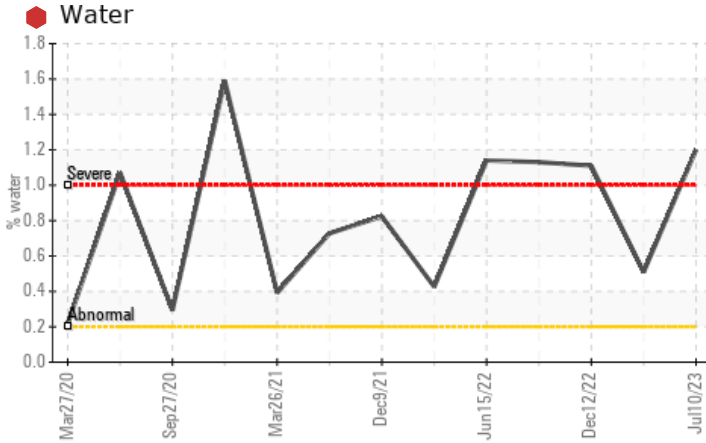
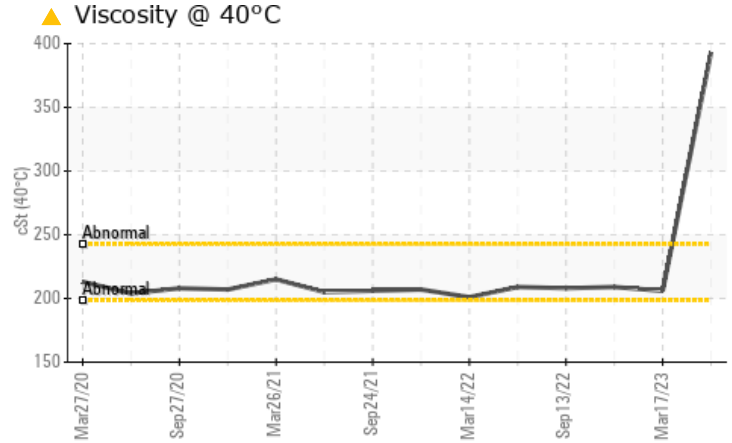
COMPONENT CONDITION SUMMARY

Sample Status				SEVERE	ABNORMAL	SEVERE
Water	%	ASTM D6304	>0.2	🔴 1.20	🟡 0.509	🔴 1.11
ppm Water	ppm	ASTM D6304	>2000	🔴 12000	🟡 5090	🔴 11100
Appearance	scalar	*Visual	NORML	🟡 HAZY	NORML	🟡 HAZY
Emulsified Water	scalar	*Visual	>0.2	🔴 0.2%	0.2%	🔴 0.2%
Visc @ 40°C	cSt	ASTM D445		🟡 393	206	209

We advise that you check for the source of water entry. We advise that you follow the water drain-off procedure for this component, and use off-line filtration to improve the cleanliness of the system fluid. We recommend an early resample to monitor this condition.

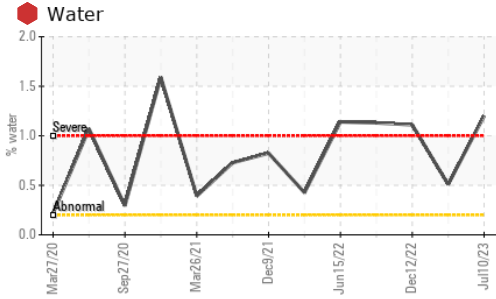
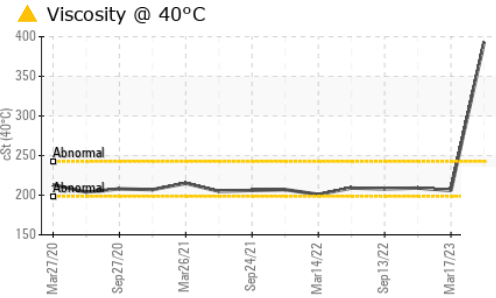
Appearance is hazy. There is a high concentration of water present in the oil.

The oil viscosity is higher than normal. Confirm oil type.

FLUID PROPERTIES		method	limit/base	current	history1	history2
Visc @ 40°C	cSt	ASTM D445		▲ 393	206	209

We advise that you check for the source of water entry. We advise that you follow the water drain-off procedure for this component, and use off-line filtration to improve the cleanliness of the system fluid. We recommend an early resample to monitor this condition.
