Area
NAT CUTS [BEFORE]
Machine Id
LINE 2 CUBER
Component
Hydraulic System
Fluid
AW HYDRAULIC OIL ISO 460 (--- GAL)

Customer Id: KRASPRMO
Sample No.: PCA0100107
Lab Number: 05929564
Test Package: IND 2

OIL ANALYSIS REPORT

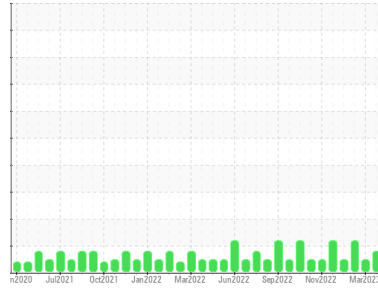
SEDIMENT

There is a moderate amount of visible silt present in the sample.

We recommend you service the filters on this component. Resample at the next service interval to monitor. We were unable to perform a particle count due to a high concentration of particles present in this sample.
