Machine Id
913036
 Component
Hydraulic System
 Fluid
PETRO CANADA HYDREX MV 46 (--- GAL)

Customer Id: GFL836
 Sample No.: GFL0122795
 Lab Number: 06193929
 Test Package: FLEET

OIL ANALYSIS REPORT

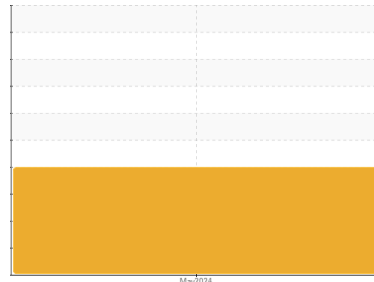
Sample Rating Trend

▲ Particle Trend

| Sample Status | | | SEVERE | --- | --- |
| Particles >4µm | ASTM D7647 | >5000 | ▲ 216964 | --- | --- |
| Particles >6µm | ASTM D7647 | >1300 | ▲ 117275 | --- | --- |
| Particles >14µm | ASTM D7647 | >160 | ▲ 407 | --- | --- |
| Oil Cleanliness | ISO 4406 (c) | >19/17/14 | ▲ 25/24/16 | --- | --- |

Check seals and/or filters for points of contaminant entry. The air breather requires service. If unrated, we recommend that you replace with a suitable micron rated and/or desiccant air breather. If rated, we recommend that you service/replace the breather. The filter change at the time of sampling has been noted. Resample in 30-45 days to monitor this situation.
